PD 23/22
Asbestos R&D Survey

Sampford Courtenay Village Hall,
Okehampton, Devon. EX20 2SY

Asbestos Survey Data Sheet

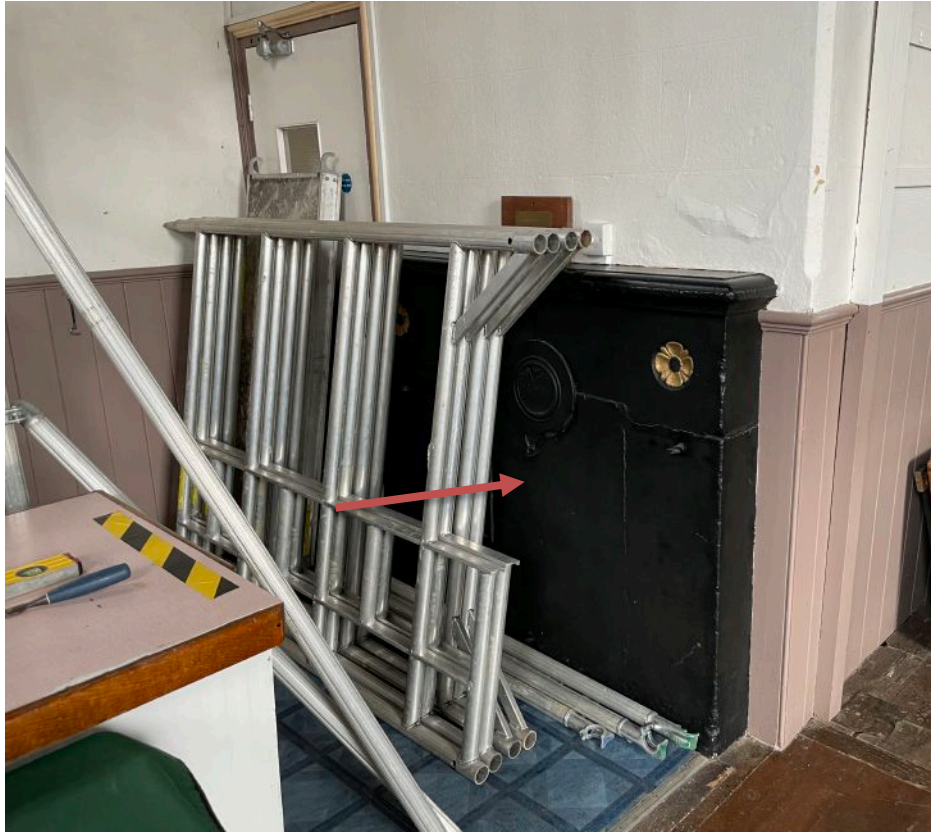
Photo 01

Plan Ref	Floor	Room	Location	Material	Quantity	Photo No.	Sampled	Condition	Risk	Comments
L01	Loft	Main Area	General View	No Asbestos Visually Detected (N.A.V.D.)						No Action Required. No roof lining, plaster from original roof fillets, man made mineral fibre insulation on timber ceilings below.
GF01	Ground	Female Toilet	General View	N.A.V.D.						No Action Required. Plasterboard ceiling, solid walls and concrete floor
GF02	Ground	Side entrance	General View	N.A.V.D.						No Action Required. Timber ceiling, solid walls and concrete floor
GF03	Ground	Main Hall	Fire place & associated chimney	No Access Within	Unknown	01	Presumed	Good	Very Low	Refer to recommendations. Timber ceiling, solid walls
GF03	Ground	Main Hall	Wall cladding internally	No Access Within	Unknown	02	Presumed	Good	Very Low	Refer to recommendations.
GF04	Ground	Entrance Hall	General View	N.A.V.D.						No Action Required. Timber ceiling, solid walls and concrete floor

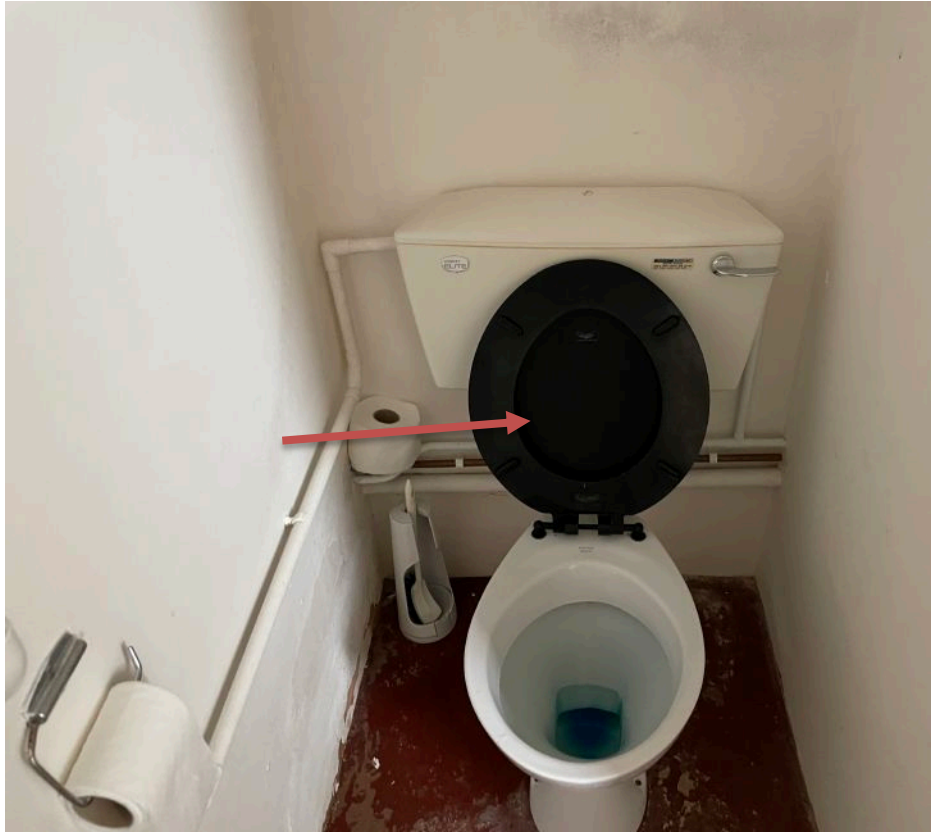
Photo 03

GF05	Ground	Male Toilet	Toilet Seat	Bakelite	X1	03	Presumed	Good	Very Low	Monitor. Refer to recommendations Plasterboard ceiling, solid walls, concrete floor

- Bakelite has been presumed in this report to be the toilet seat in the male toilet. The material is visibly in good condition, so it has been recommended that it remains insitu and is monitored, as it is outside of the scope of works. The material is classed as very low grade, very low risk and non licensable.

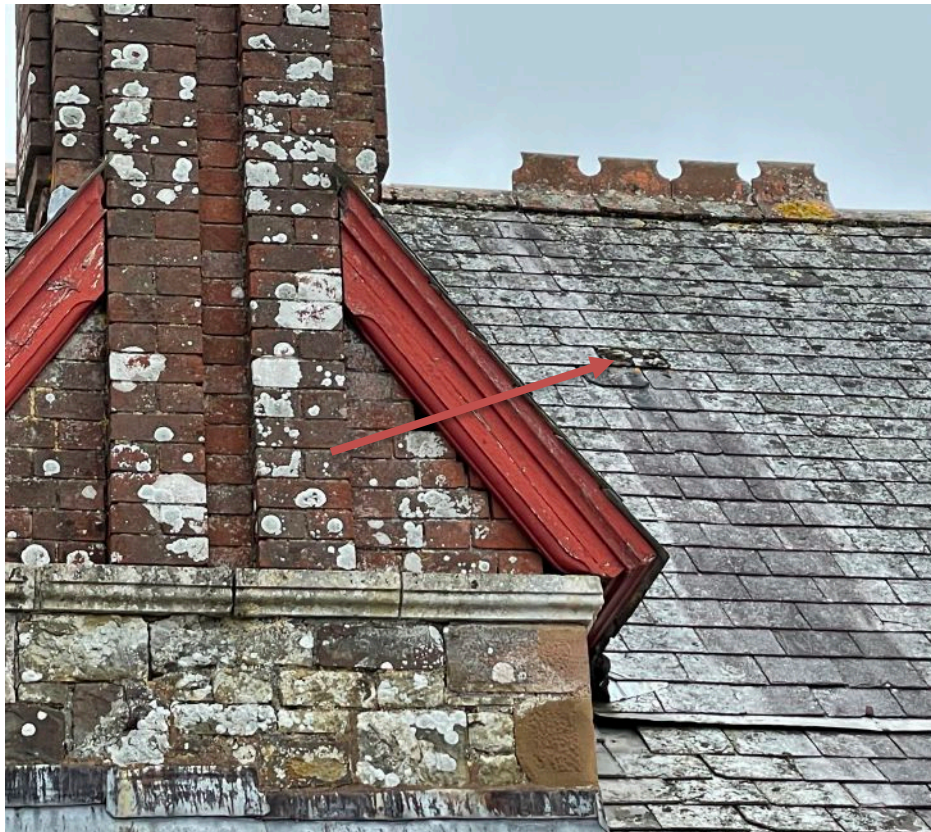
Photo 04

-	External	Roof	Replacement tiles	Asbestos Cement	X5 visible	04	Strongly Presumed	Good	Low	Remove. Non Licensable.
-	External	Roof	Barge board lining panel to toilet roof	Board		05	PD23022 2/01			No Asbestos Detected In Sample (N.A.D.I.S.). No action required

- There are visible asbestos cement replacement roof tiles on the roof and are easily identifiable as they attract clumps of moss, as the protective layer of the tile wears away, exposing the asbestos fibres which allows the moss to cling on to them. Asbestos cement is classed as low grade, low risk and non licensable, which means a licensed contractor is not required to remove the material, however they should have the relevant certification and the associated insurances.
