the play inspection company

Annual Inspection

Sampford Courtenay Parish Council

Sampford Courtenay Village Green

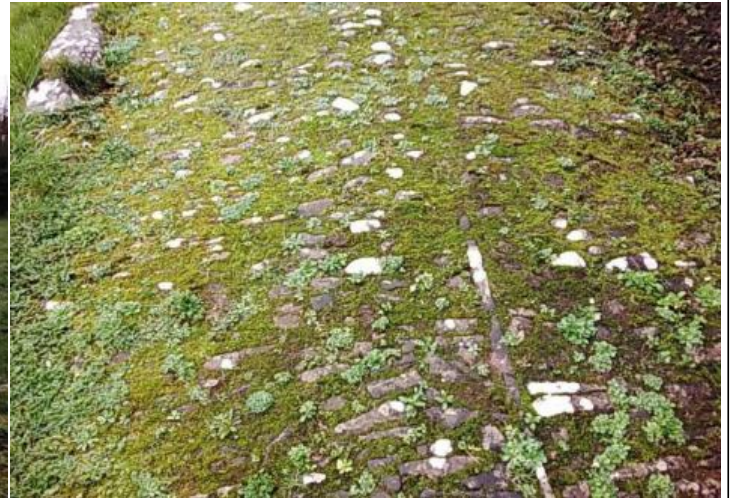
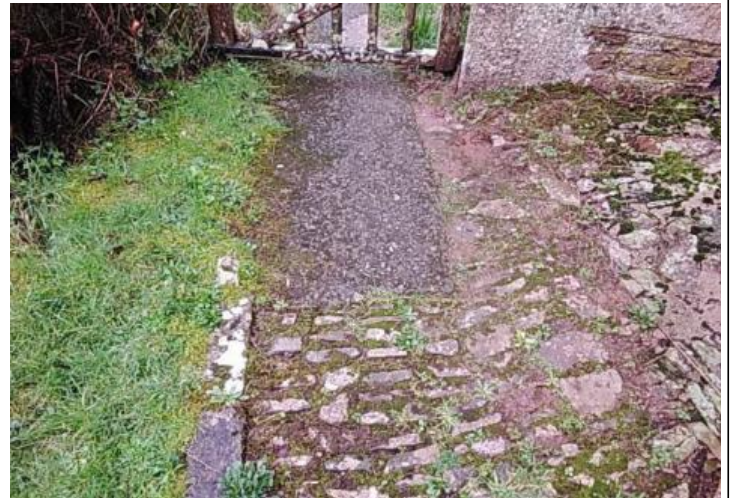
Finding: There is algae, silt or moss growth on the footpath surface resulting in slippery conditions
Action: Clean and treat appropriately

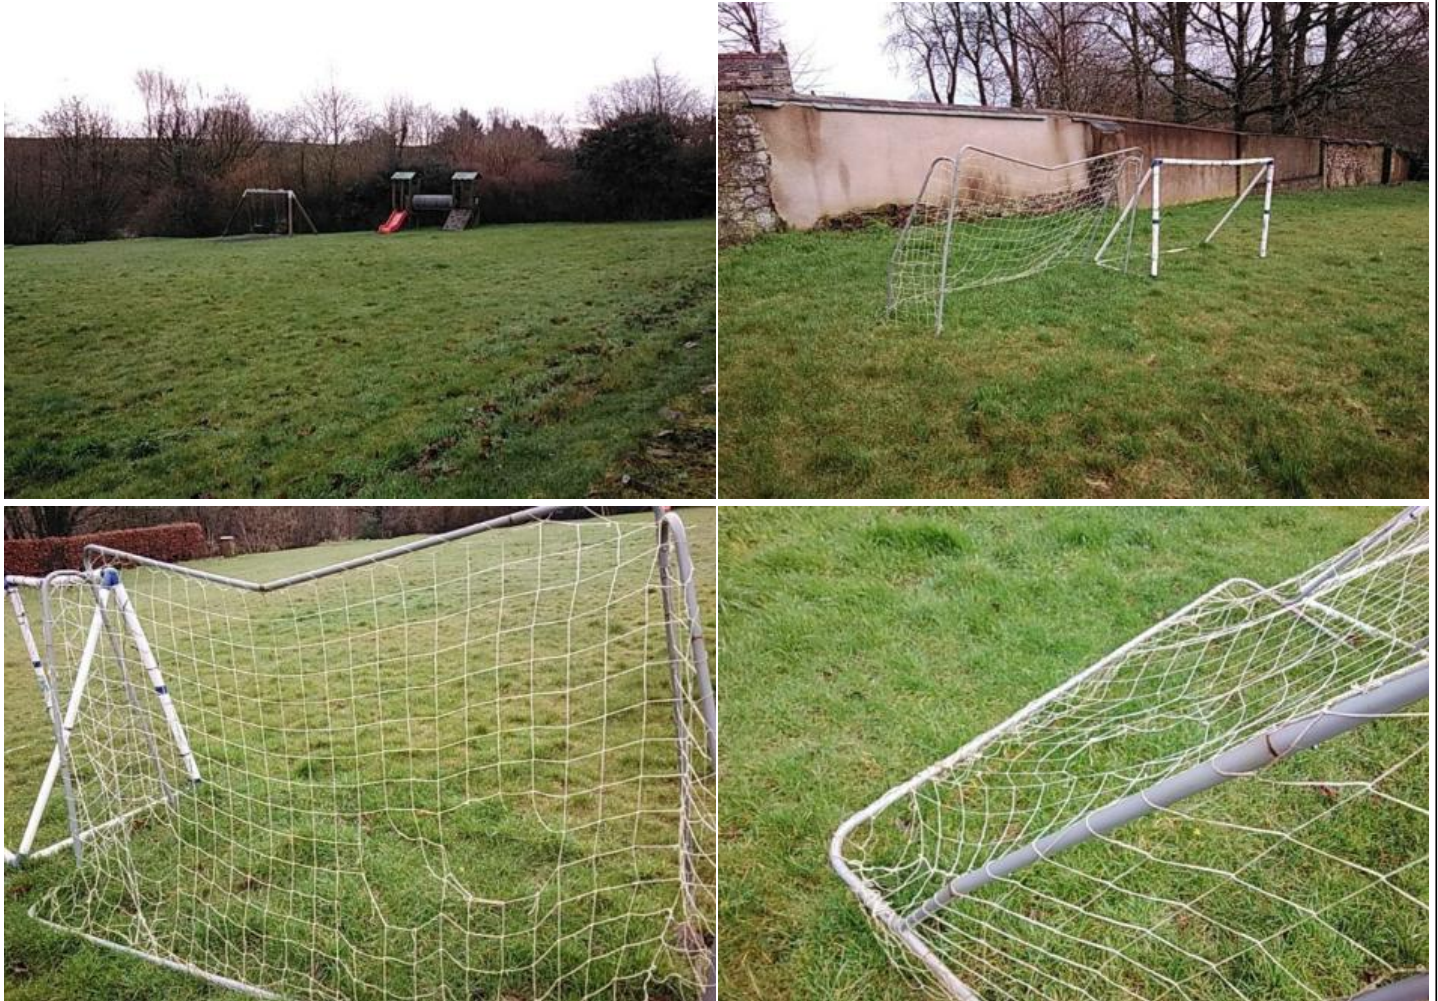
Finding: There are two domestic, unsecured free standing goals present on site. One of the goals has significant damage. These items are unsuitable for use in a public play area.

Action: We would recommend that the goals are removed

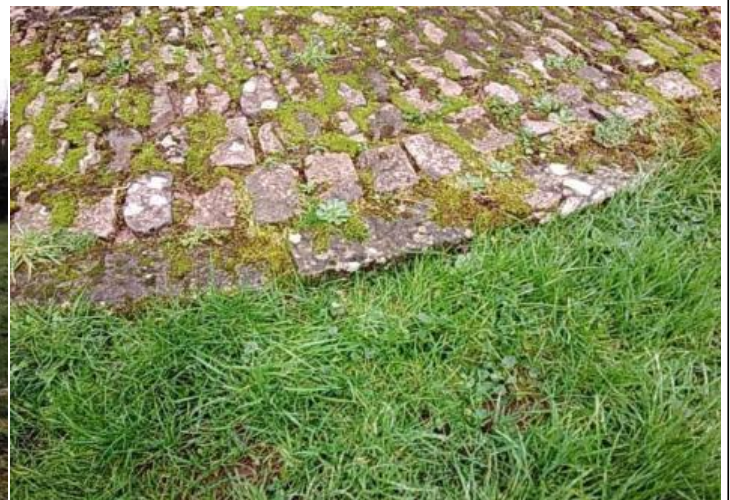
Finding: There are trip hazards present over the footpath edgings

Action: Reinstate surrounding surfaces to level to remove the trip points

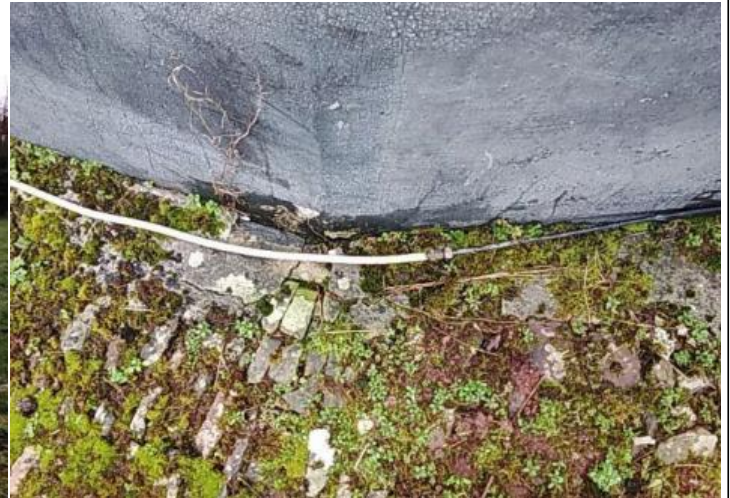
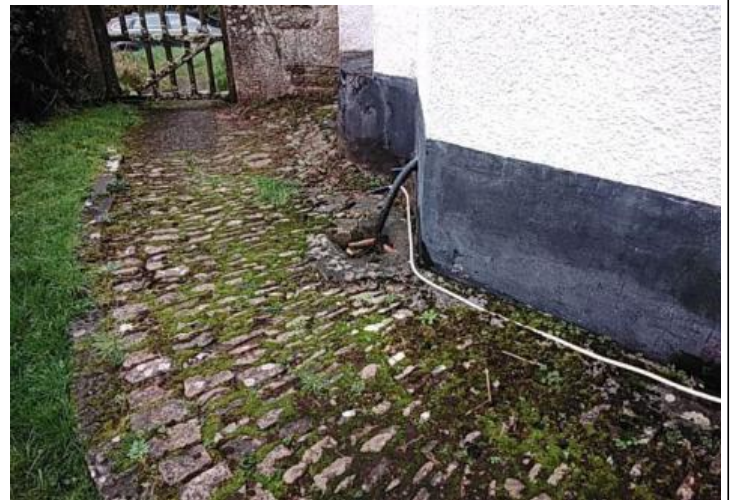
Finding: NOTE - Although not part of the inspection, the inspector note a loose cable on the building adjacent to the access point

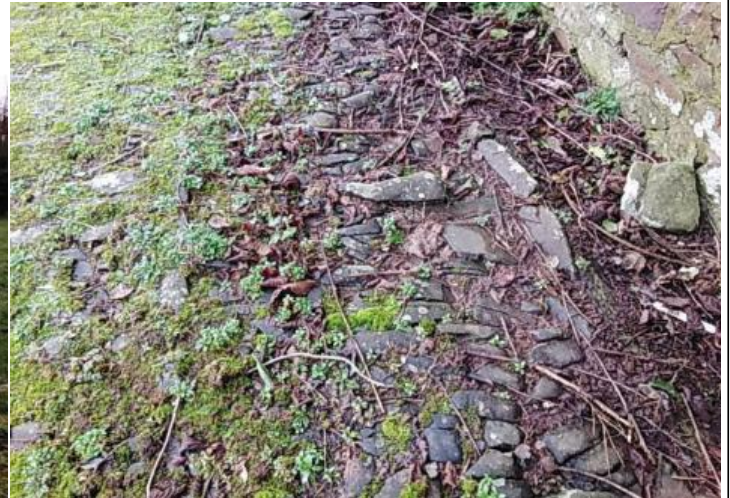
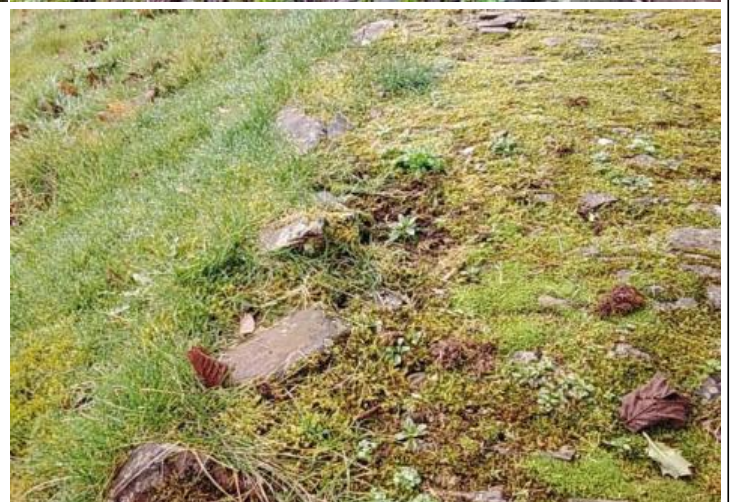
Finding: The path surface is uneven and some of the stones are loose creating potential trip points

Action: Monitor condition and usage of path and reinstate as required.

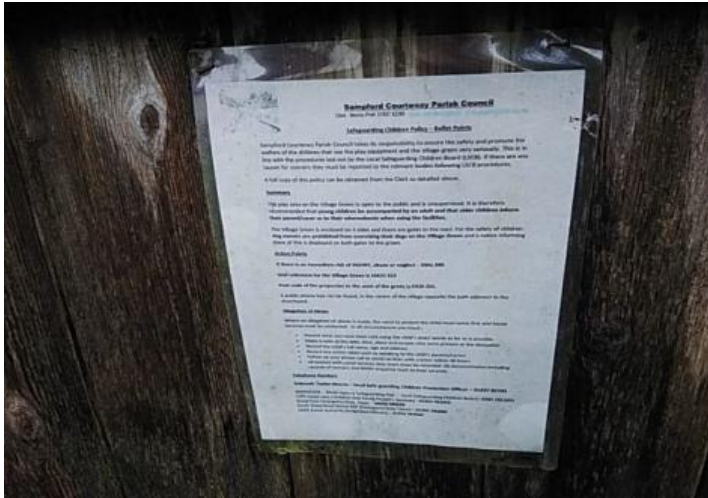
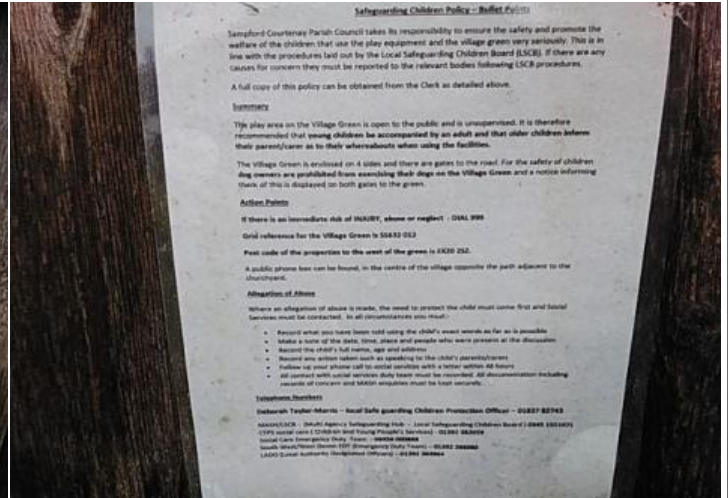
Finding: The sign is of a laminated paper type and will deteriorate over time. The text is also small and may be difficult to read for some users

Action: Consider replacement with alternative signage

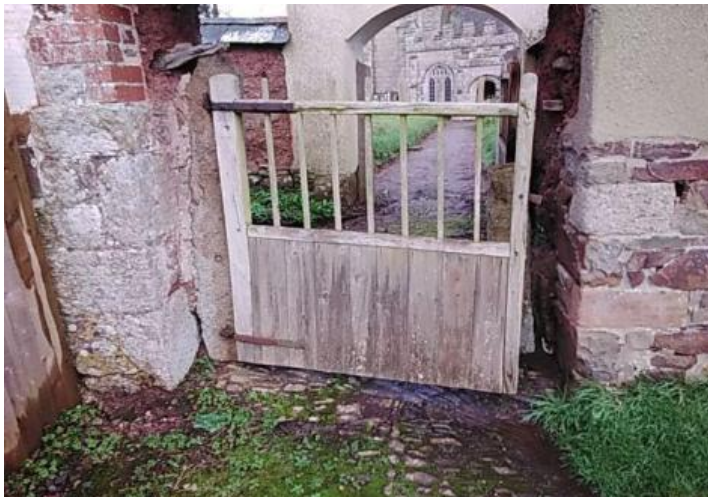
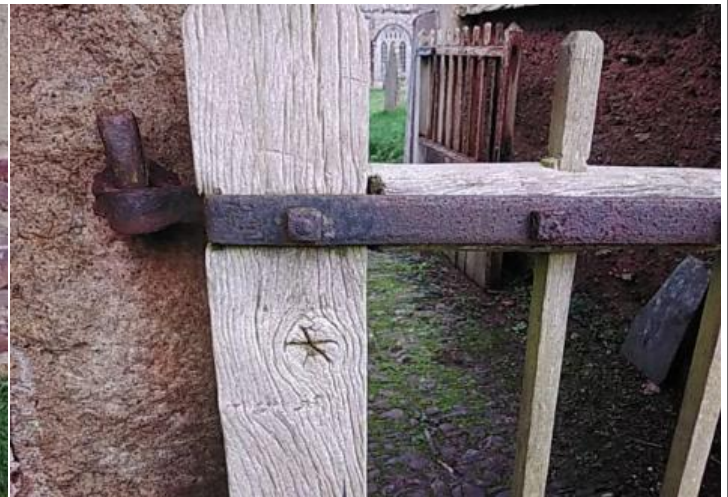
Finding: The paintwork on this item has been damaged or worn exposing the metal underneath which is rusting

Action: Treat any rusting components and repaint

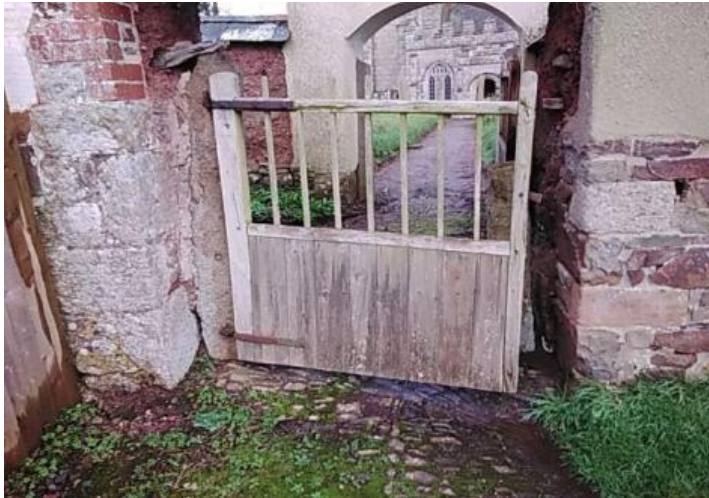
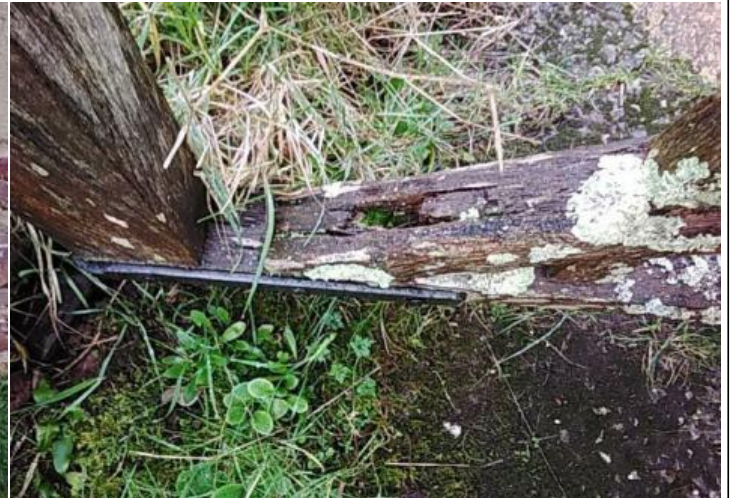
Finding: There are areas or parts of the timber on the structure that have rotted

Action: Replace all affected timbers

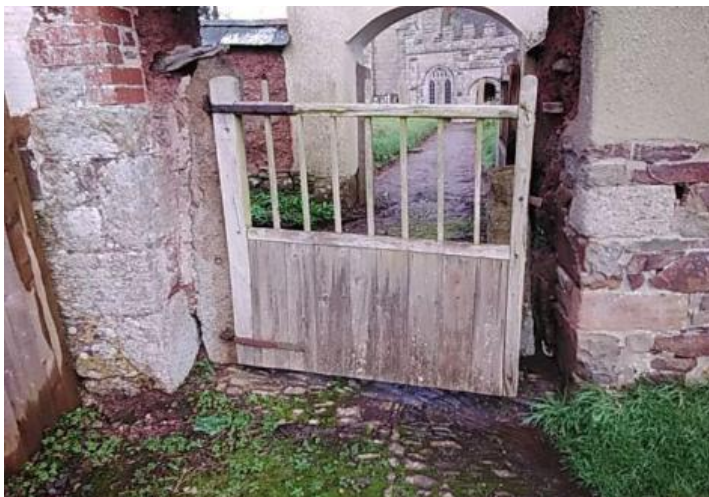
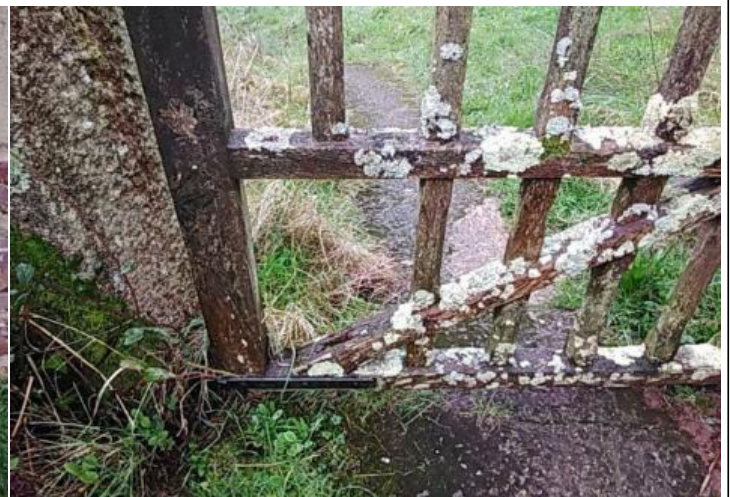
Finding: The item has missing component(s)

Action: Consider replacing missing components

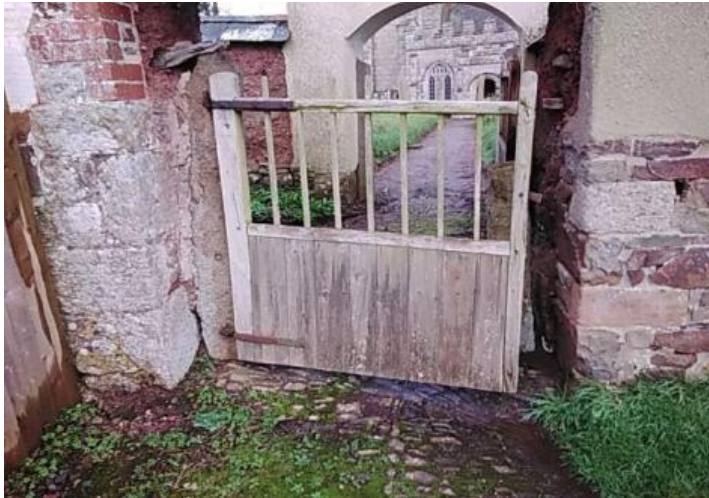
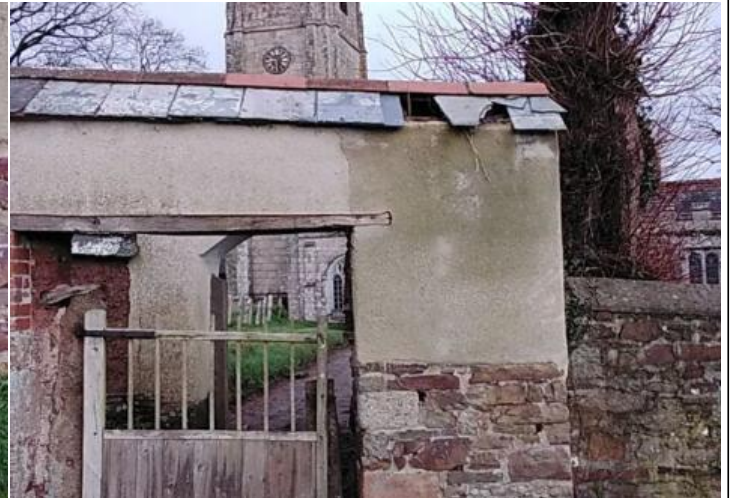
Finding: NOTE - Although not part of the inspection, it was noted that the adjacent roof and wall had some damage present.

Action: We would recommend that these structures are made safe

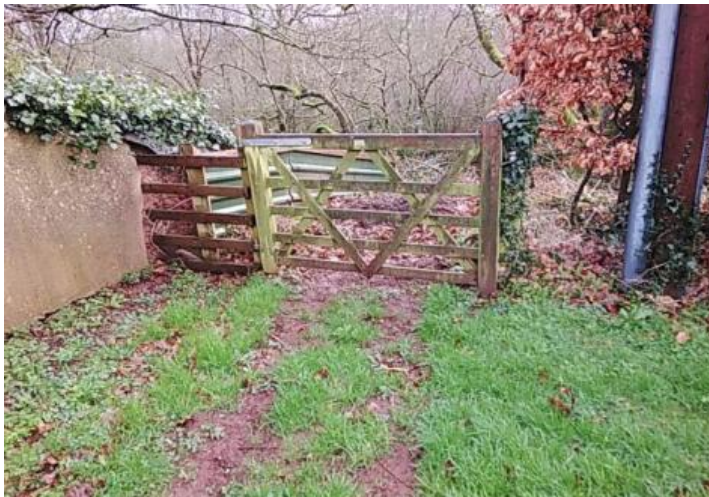
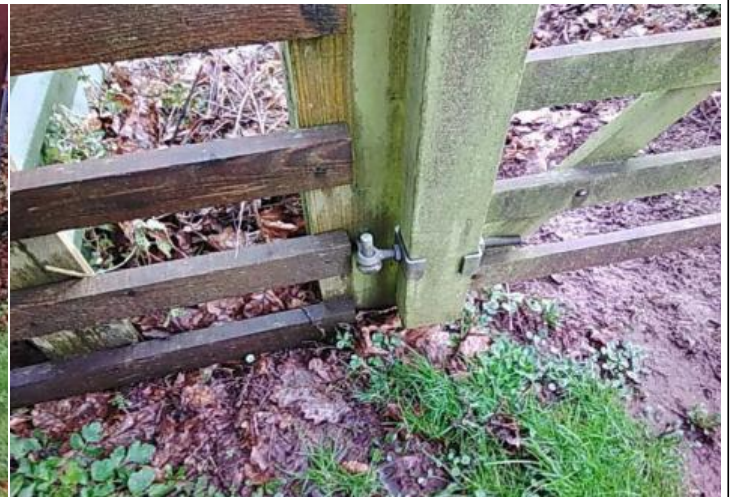
Finding: The item is slightly loose in its foundations

Action: Monitor for any further deterioration and repair as required

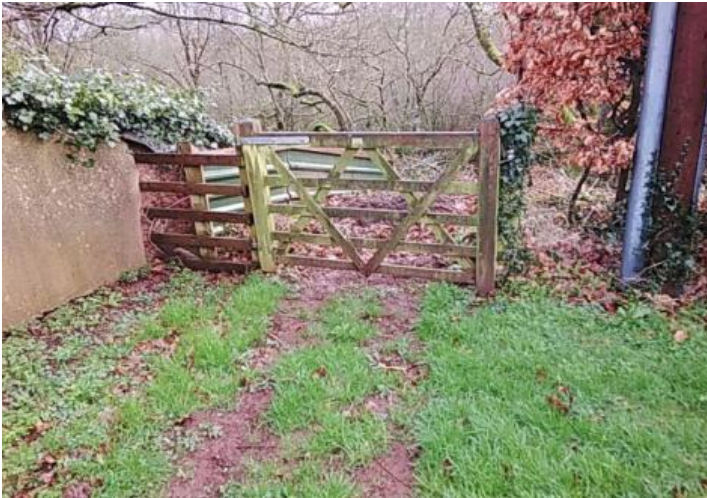
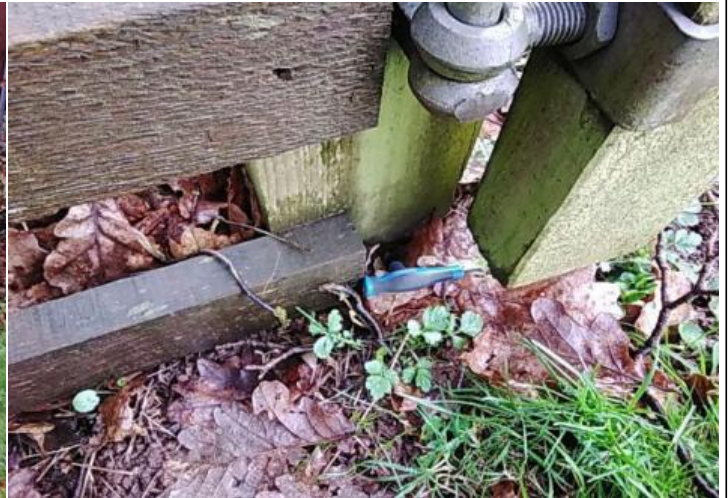
Finding: There are areas or parts of the timber on the structure that have rotted

Action: Replace all affected timbers

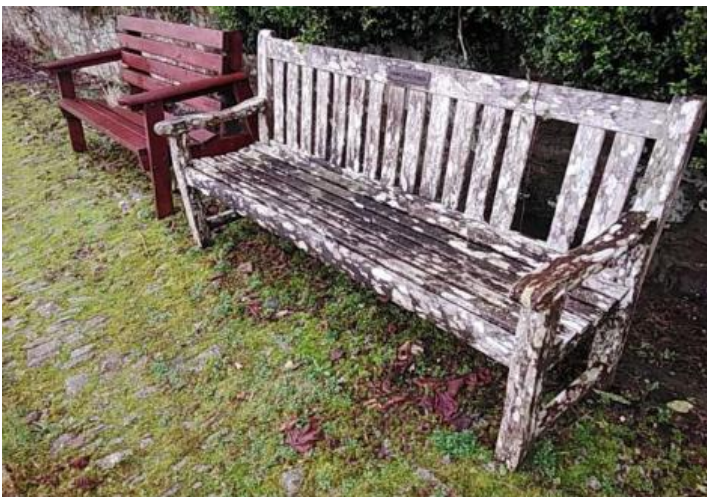
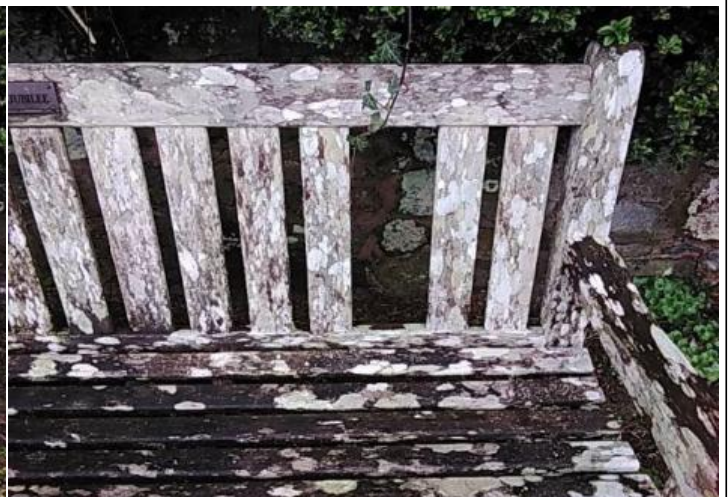
Finding: There are a number of timber slats missing from the bench

Action: Replace missing slats

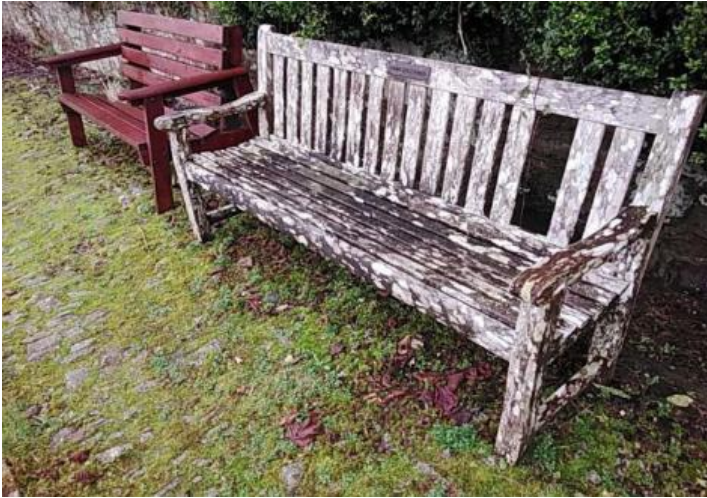
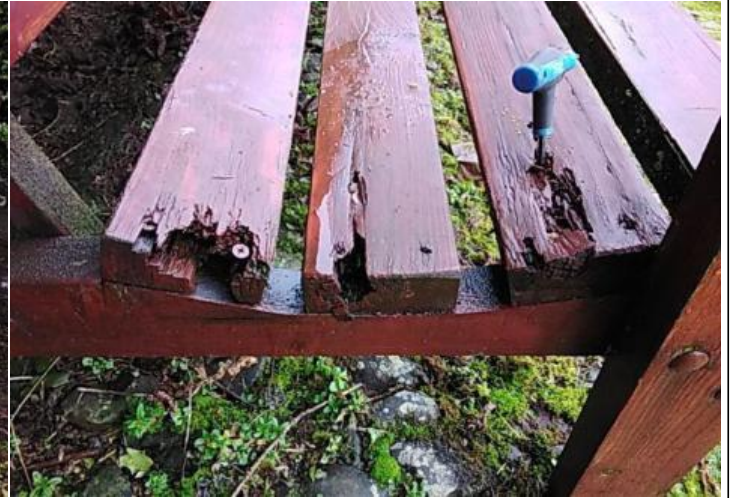
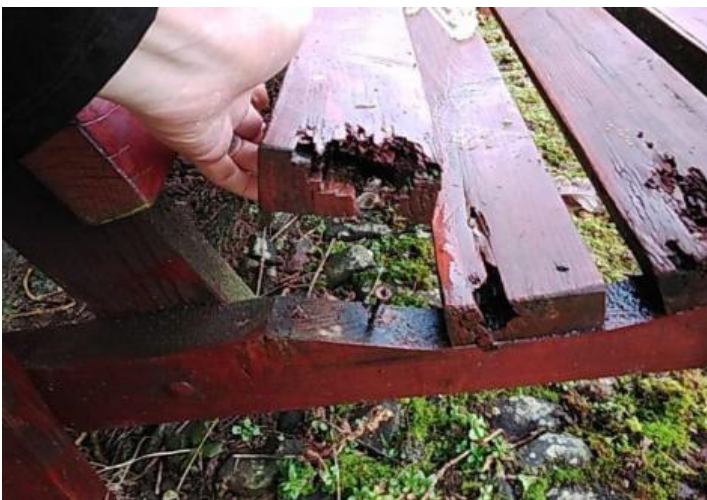
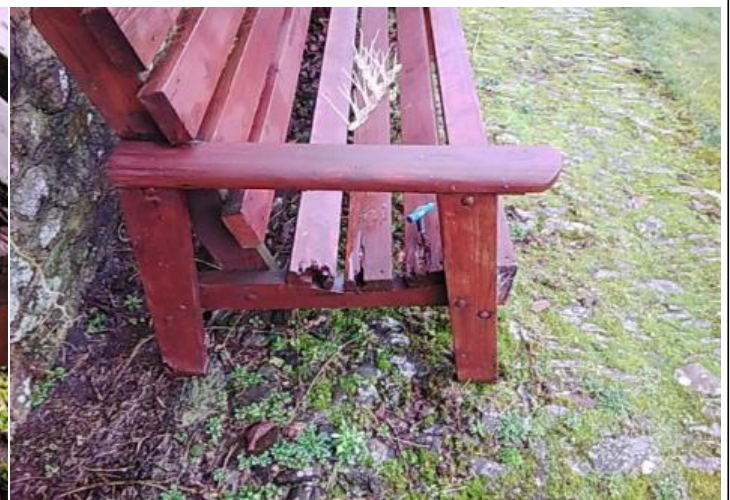
Finding: There are areas or parts of the timber on the structure that have rotted through structural integrity of the slats cannot be determined

Action: Replace all affected timbers

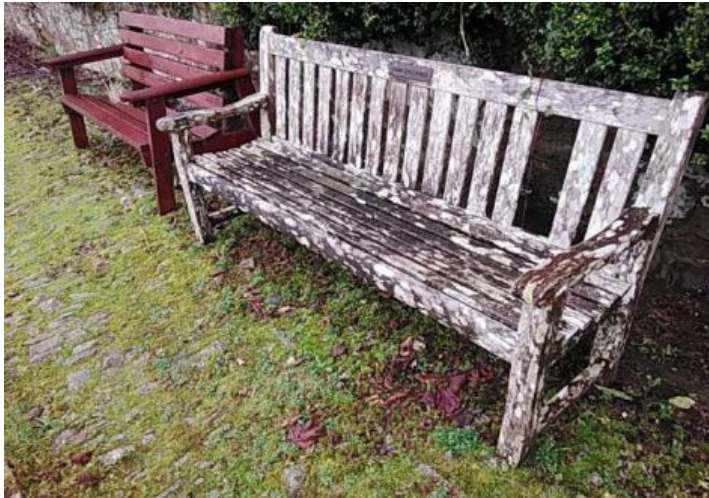
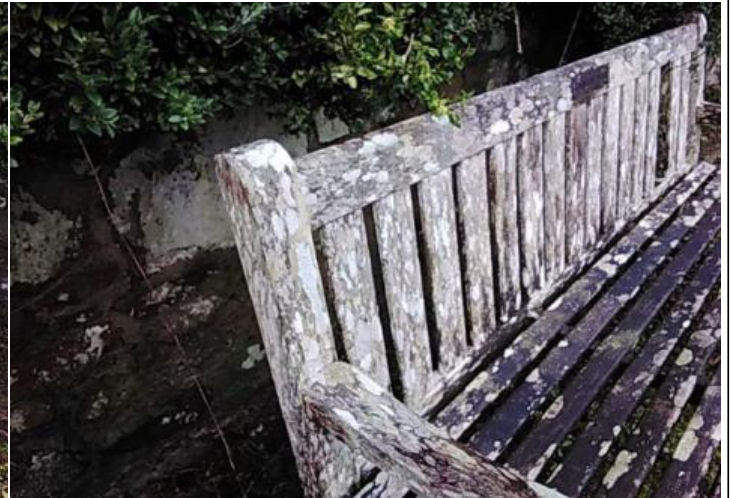
Finding: The timber stain is in poor condition

Action: Prepare all affected parts and re-stain with an appropriate preservative

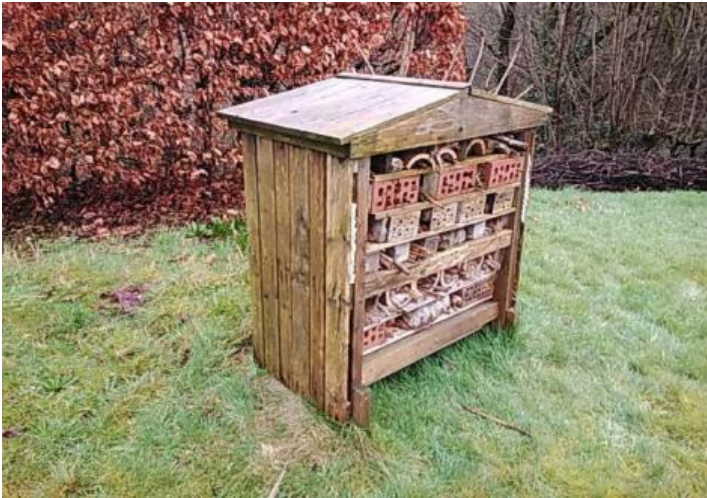
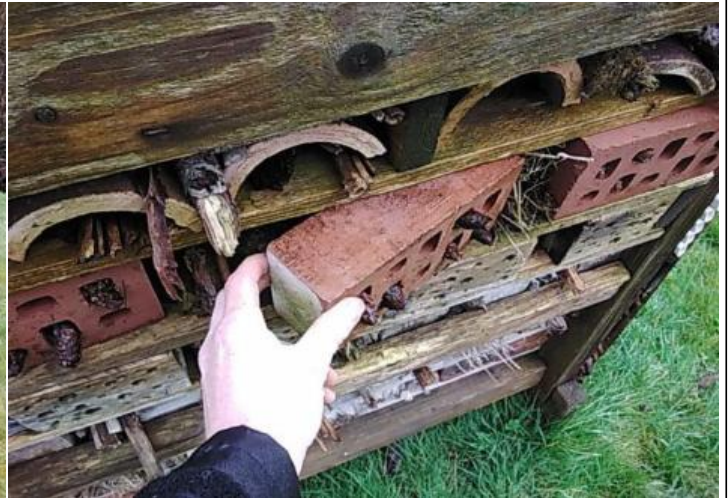
Finding: There are a number of loose items within the structure, these items may fall out or be subjected to mis-use.

Action: Ensure that an appropriate risk assessment is in place, monitor use and secure or remove as required

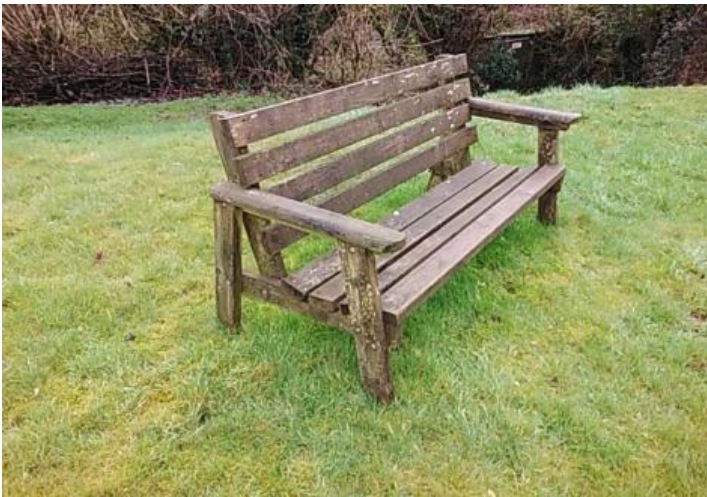
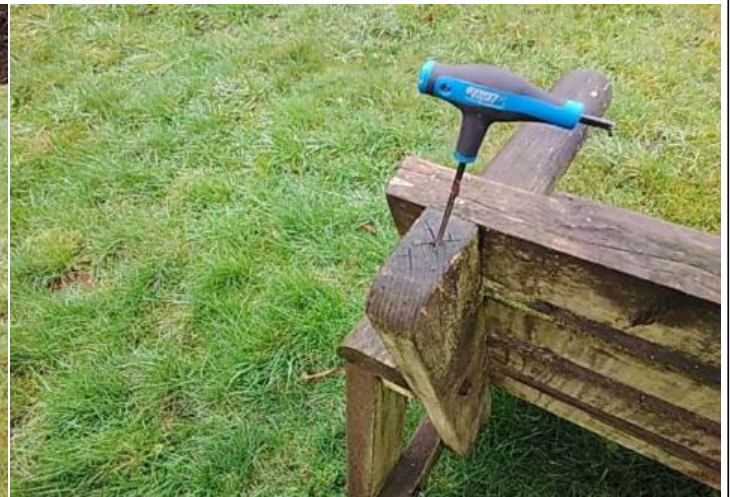
Finding: There is some evidence of rot in the timber

Action: Monitor for any further deterioration and replace as required

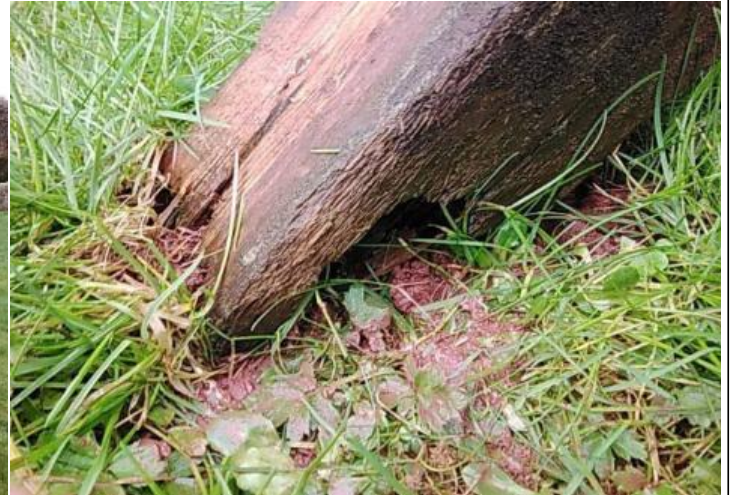
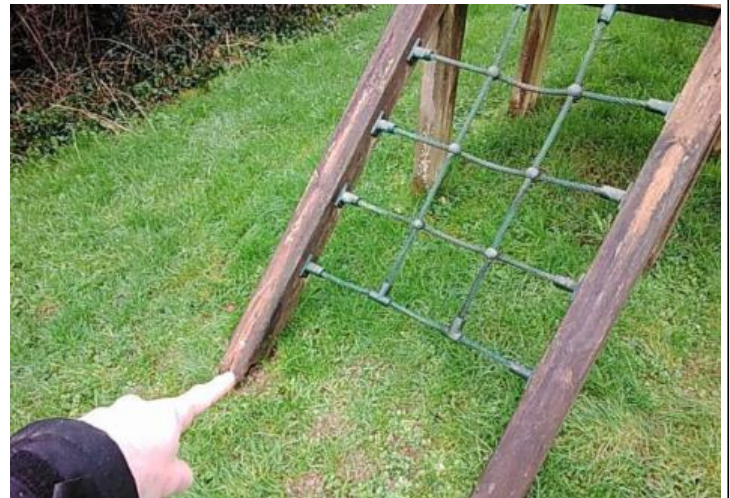
Finding: There are areas or parts of the timber net frame on the structure that have rotted and sheared
Action: Replace all affected timbers

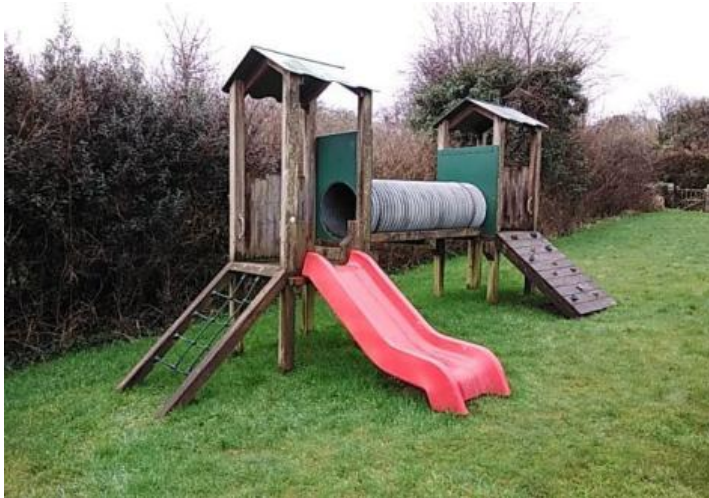
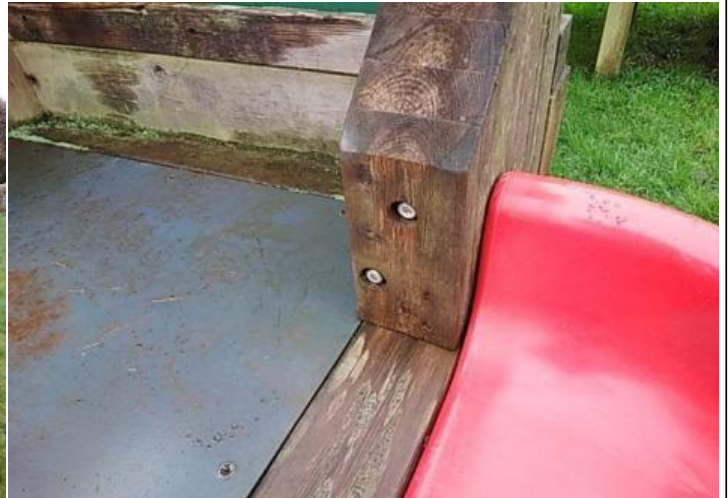
Finding: There is/are bolt cap covers missing or damaged on the item

Action: Replace missing or damaged bolt cap covers

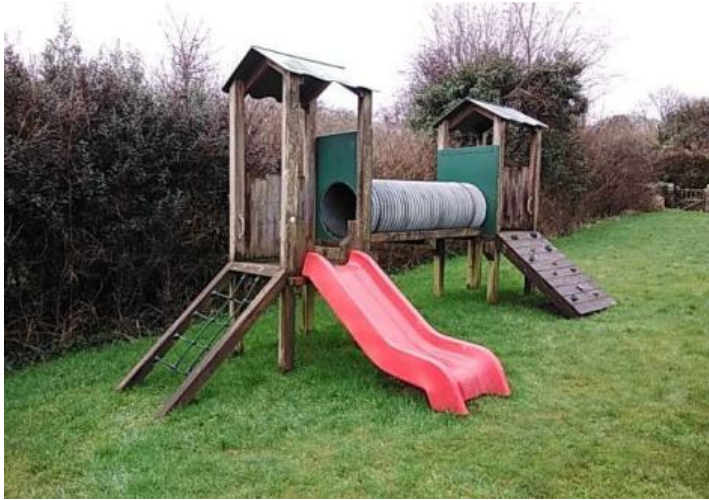
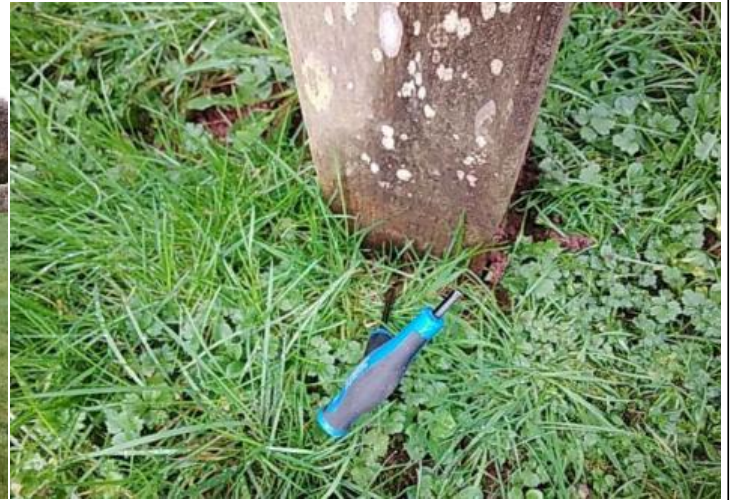
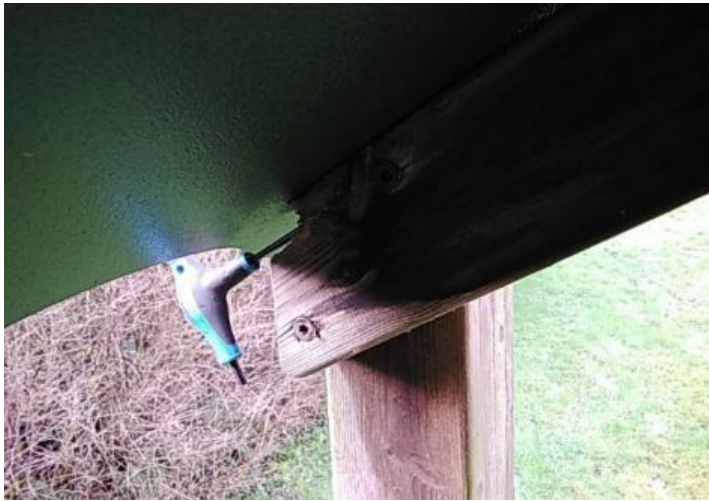
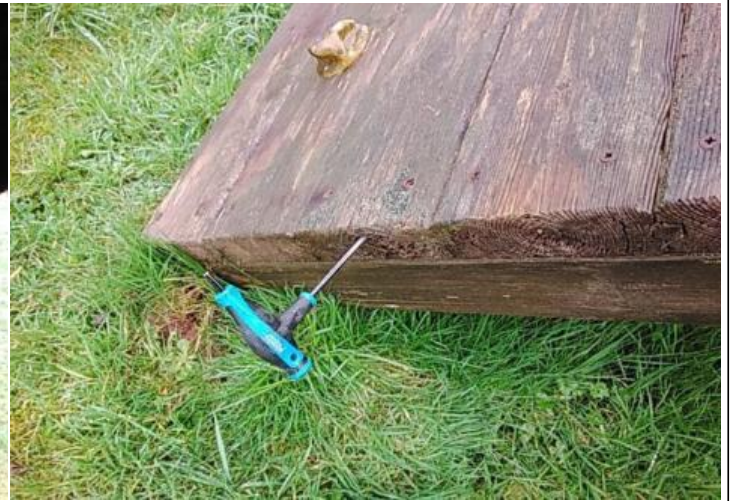
Finding: There is some evidence of rot in the timber throughout

Action: Monitor for any further deterioration and replace as required

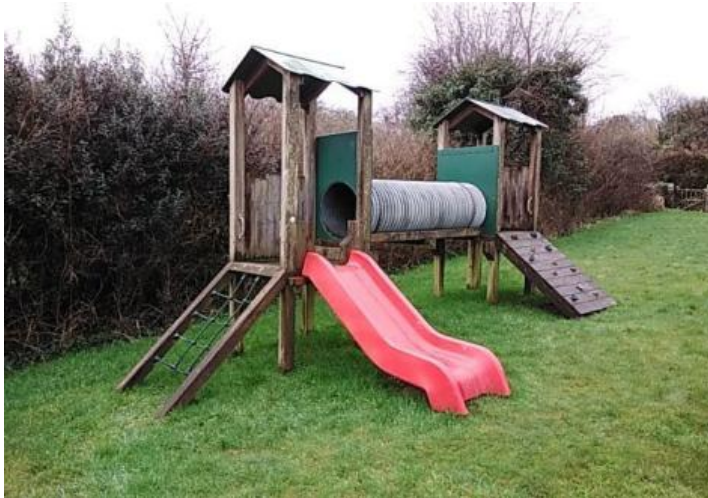
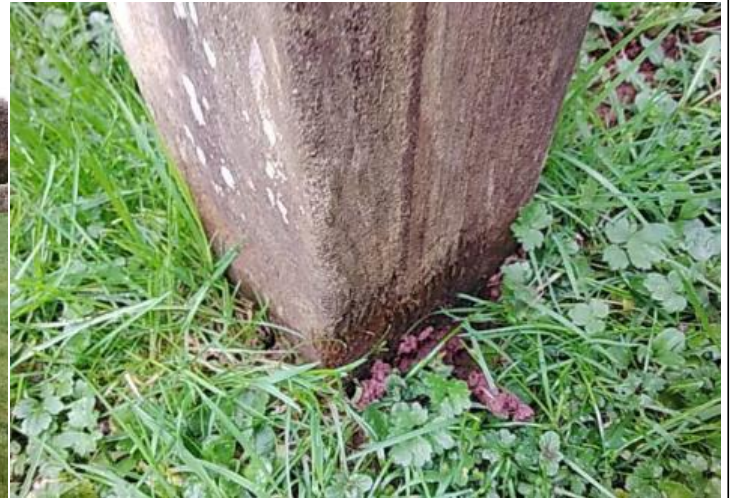
Finding: There is some strimmer / machinery damage apparent on the posts, this can penetrate the preservative applied to the timber and accelerate the rotting process

Action: Monitor for any deterioration (rot) and replace as required

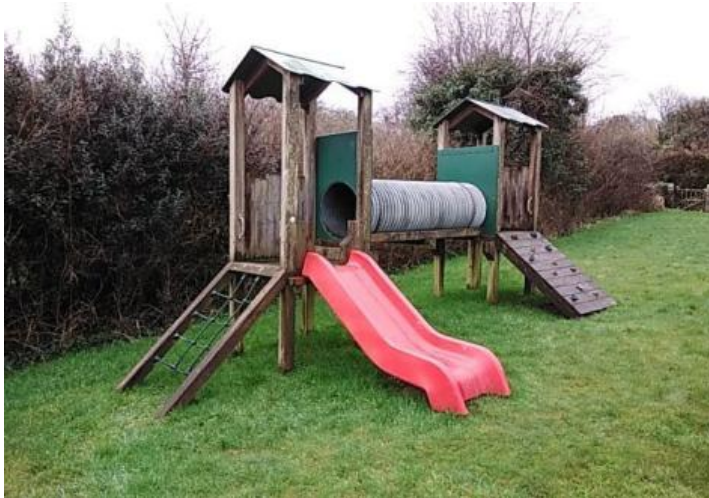
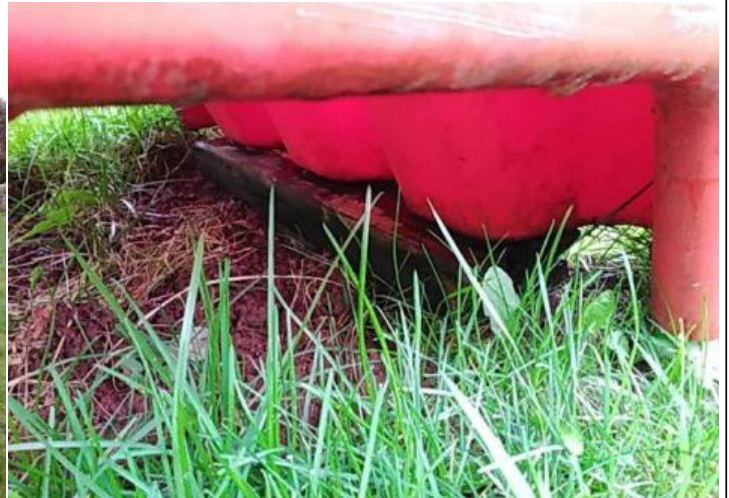
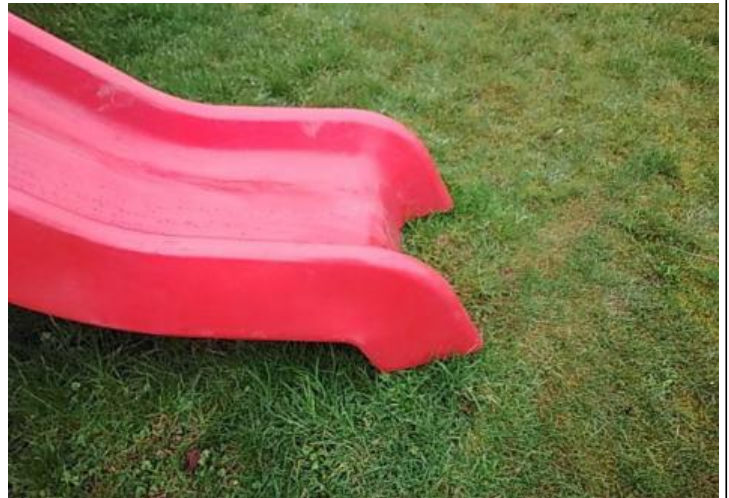
Finding: The slide is slightly loose on its mount

Action: Monitor for any further deterioration and repair as required to secure

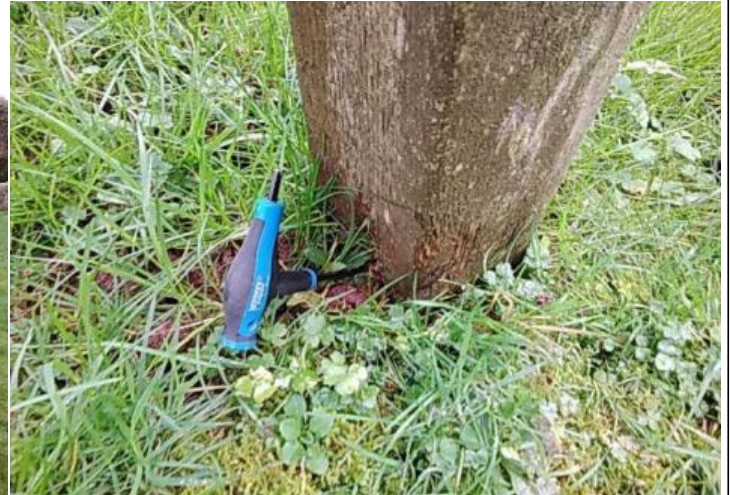
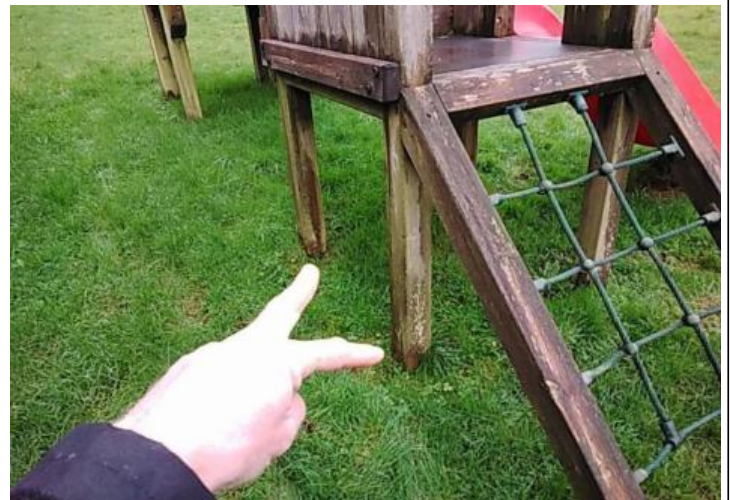
Finding: There are areas or parts of two timber posts on the slide tower that have rotted
Action: Replace all affected timbers

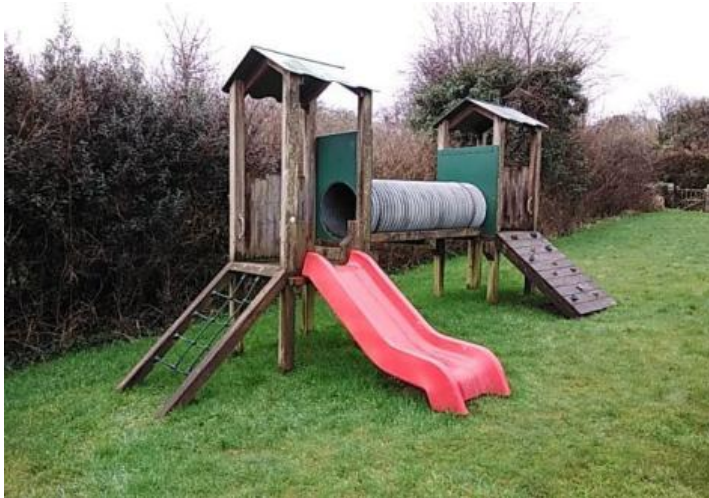
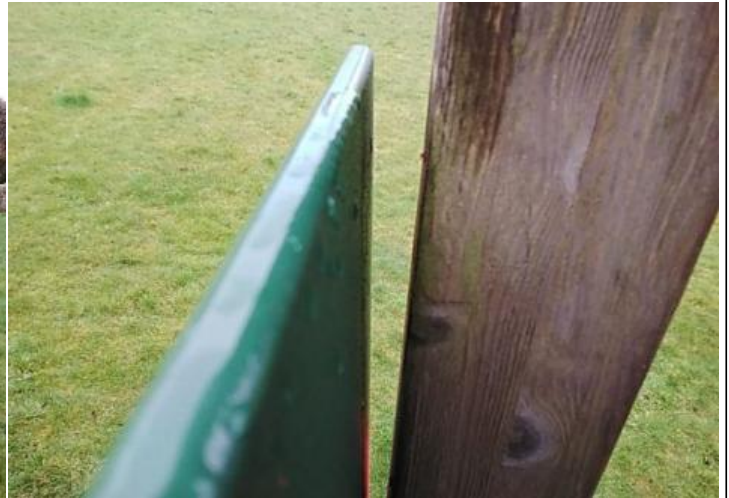
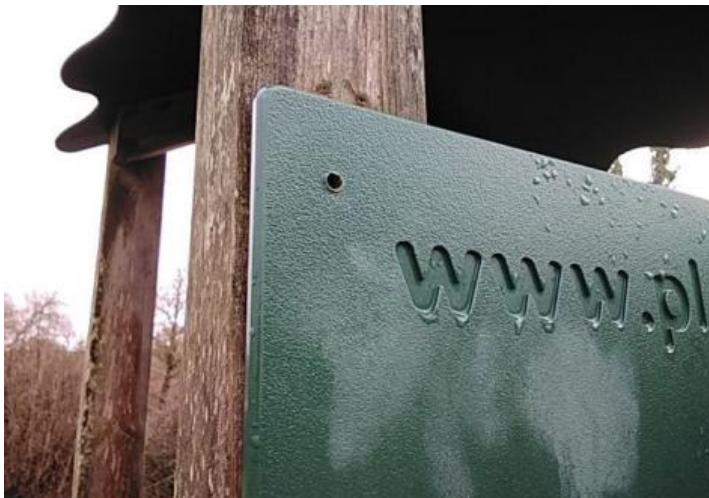
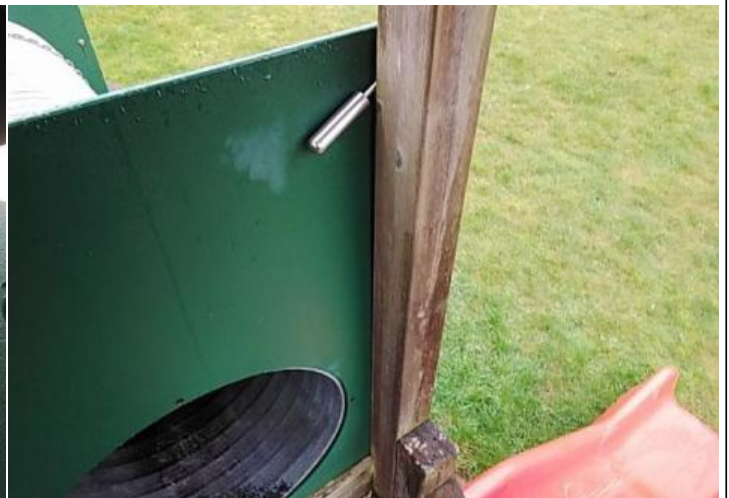
Finding: There is or are fixings missing on the tunnel surround creating a crush point in contravention of the requirements of BS EN 1176 Part 1

Action: Replace all missing fixings and secure to remove crush point

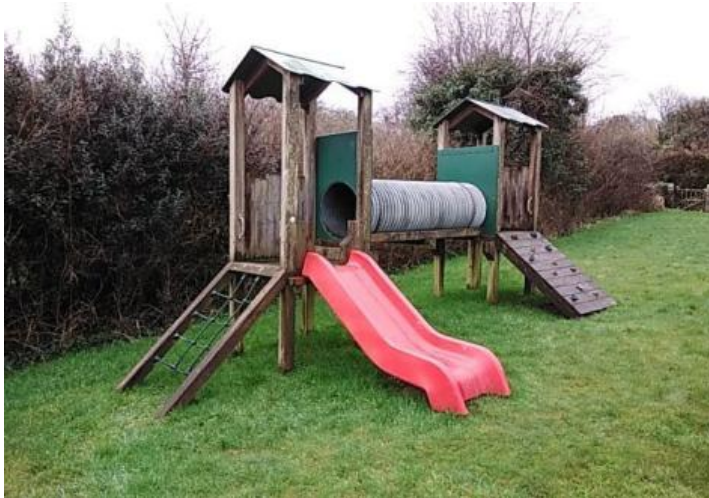
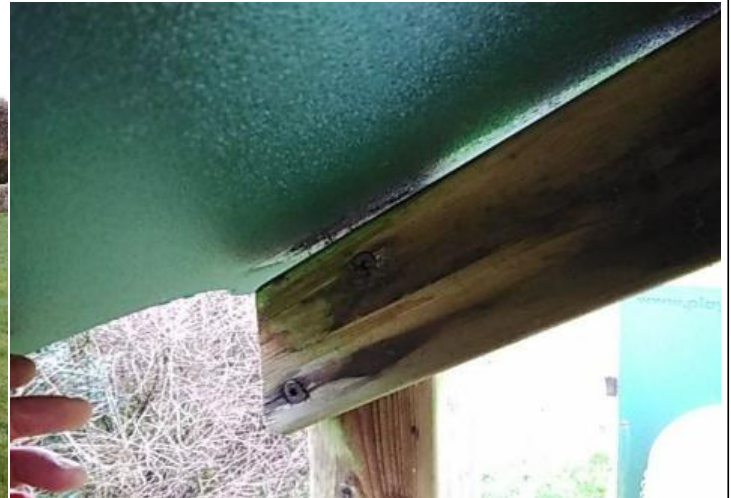
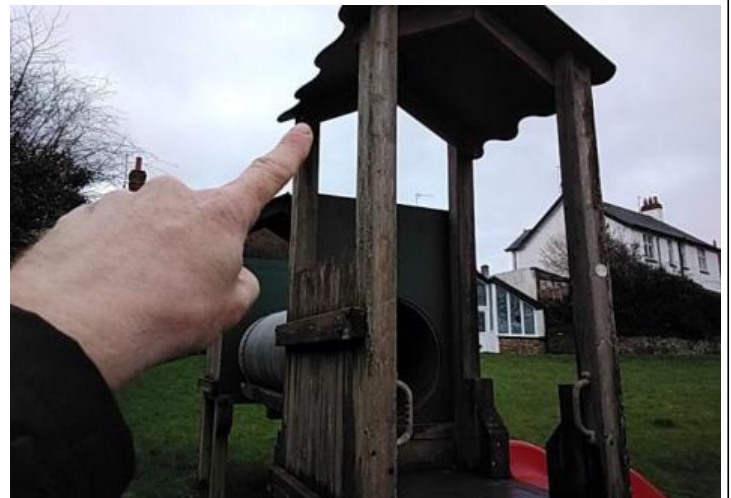
Finding: There is or are fixings missing on the roof panels

Action: Replace all missing fixings

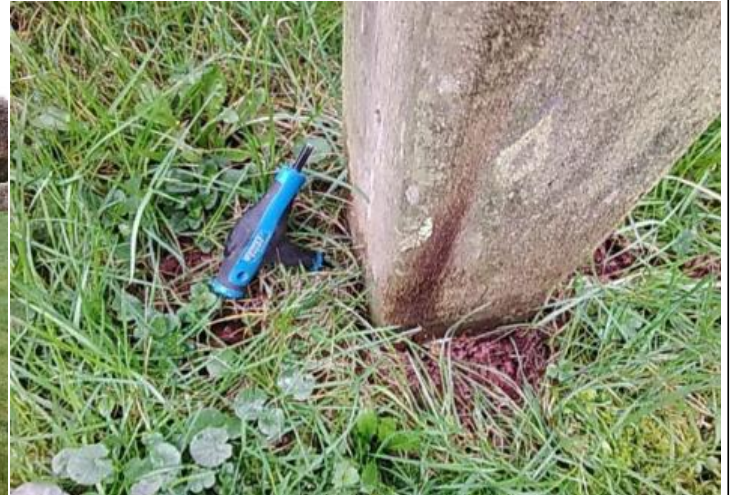
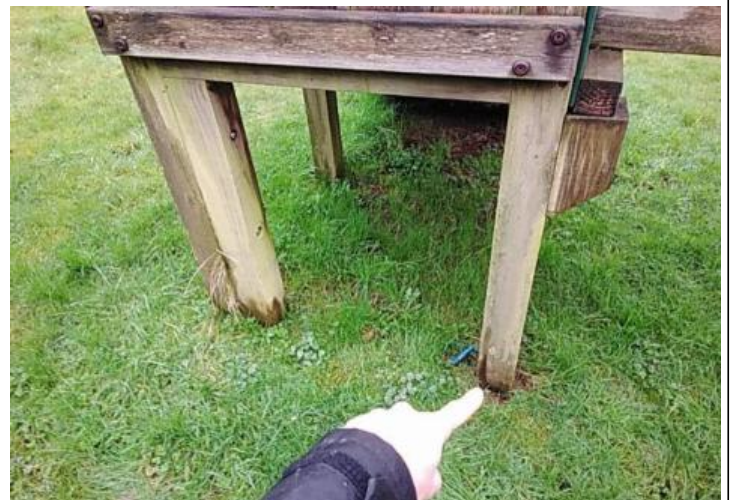
Finding: There are areas or parts of the timber post on the climb panel tower that have rotted

Action: Replace all affected timbers
