the play inspection company

Annual Inspection

Sampford Courtenay Parish Council

Sampford Courtenay Village Green

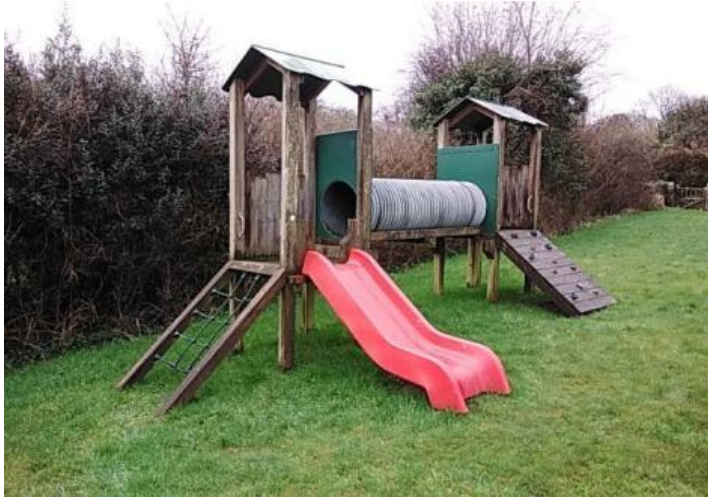
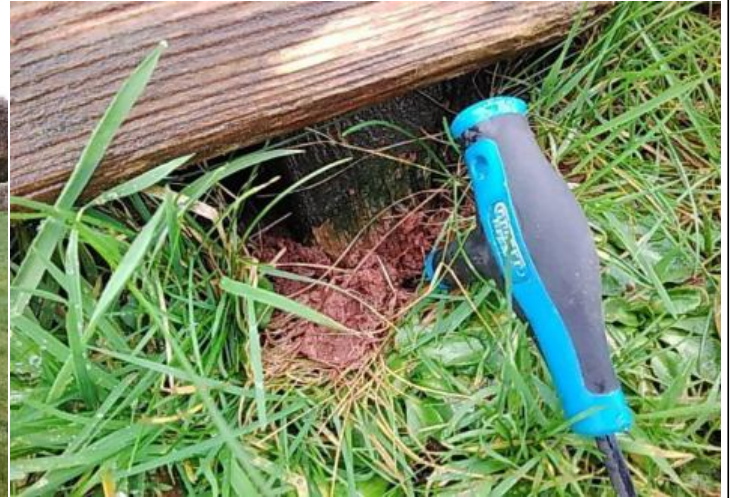
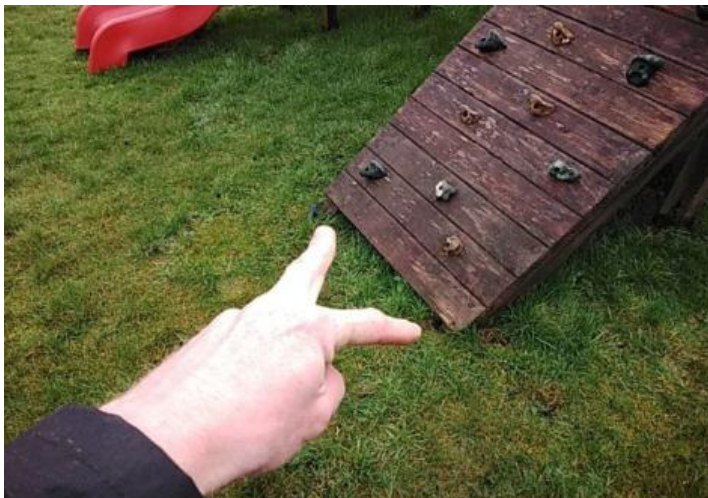
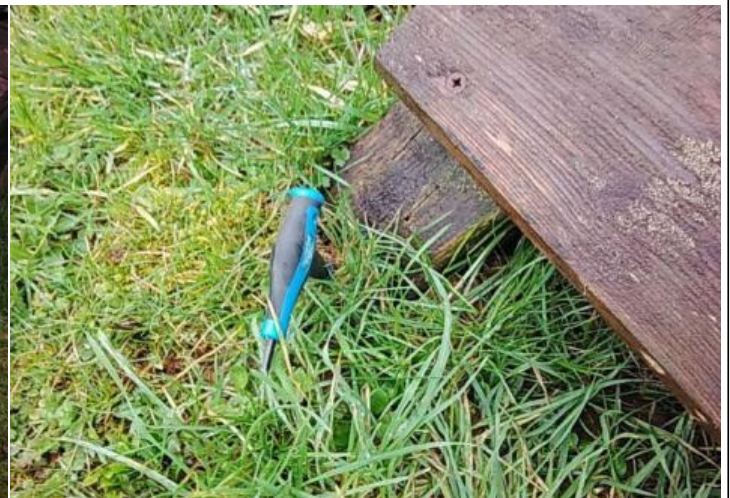
Finding: There are areas or parts of both timber climb panel supports that have rotted **Action:** Replace all affected timbers

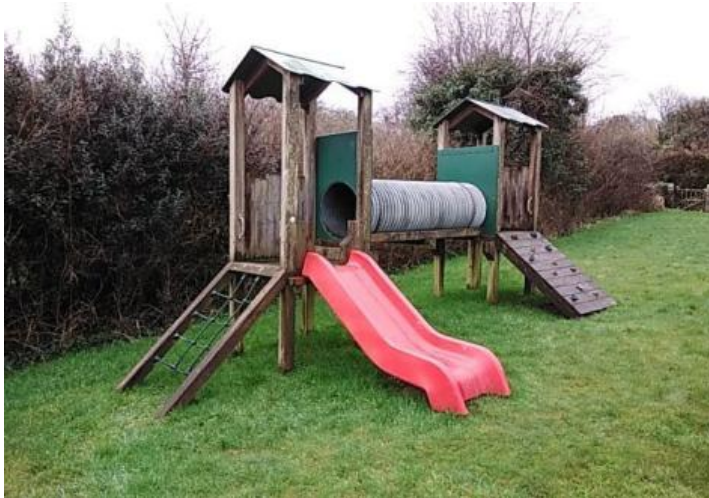
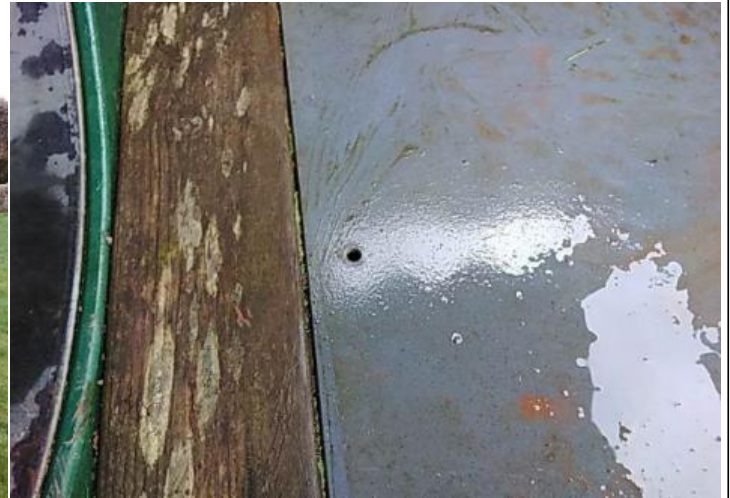
Finding: There is or are fixings missing on the platform

Action: Replace all missing fixings

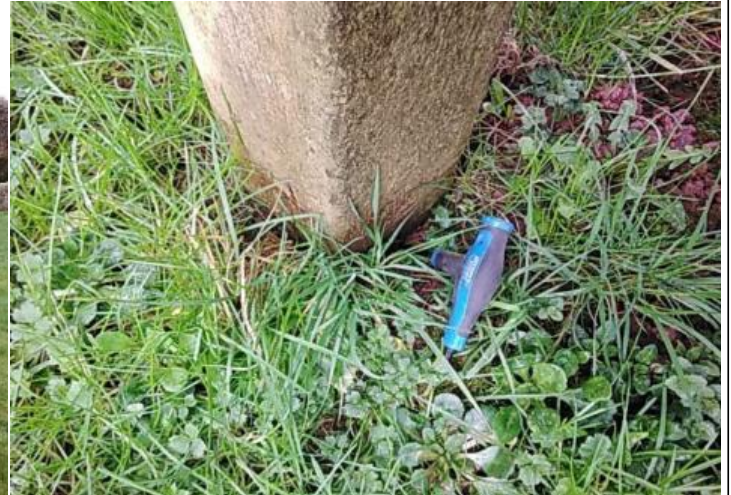
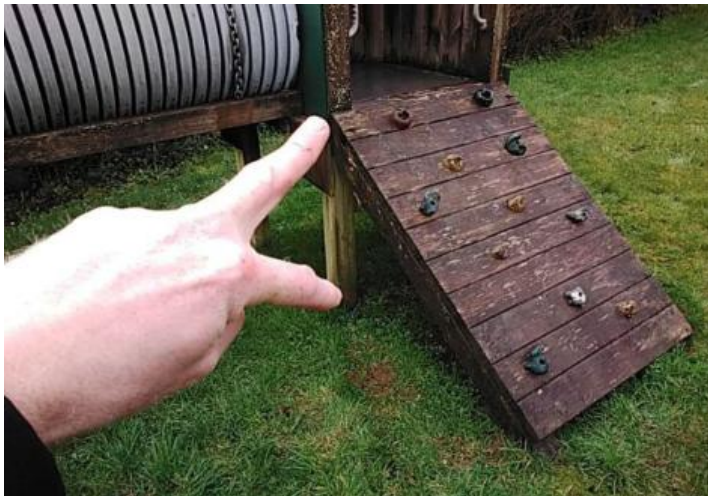
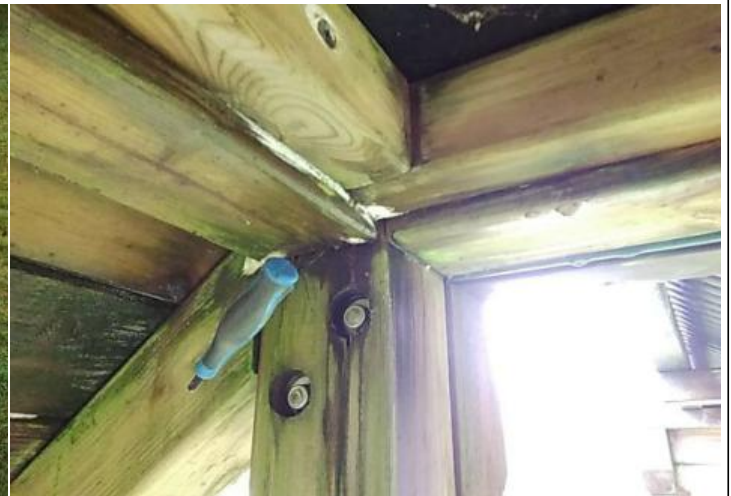
Finding: There are areas or parts of the timber post that have rotted at the base and around the area where the platform is mounted

Action: Replace all affected timbers

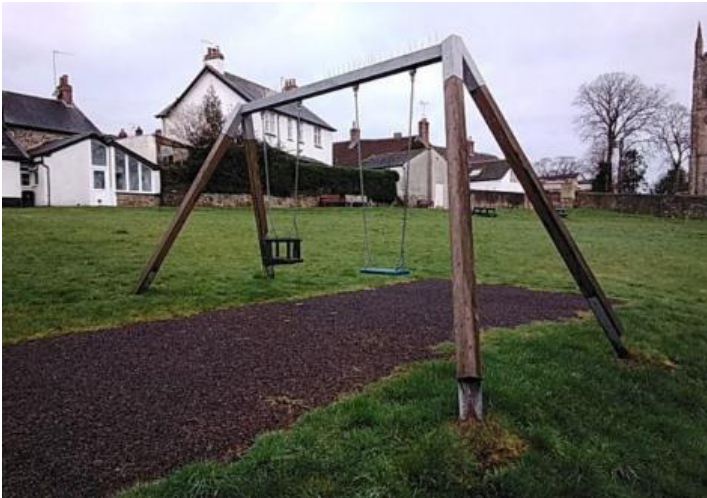
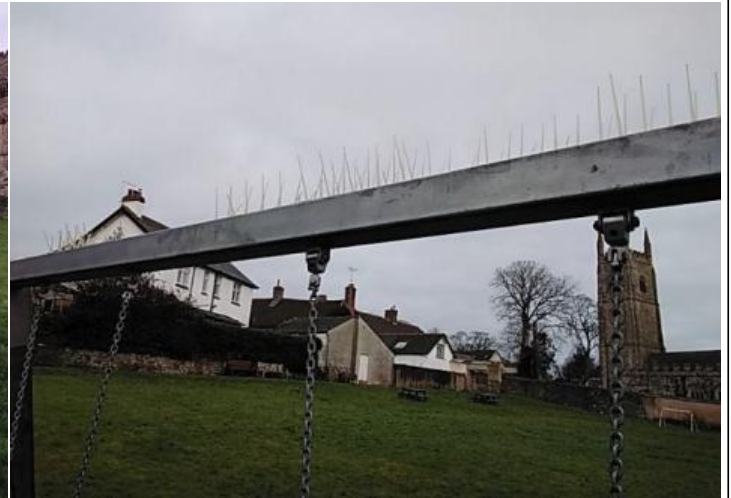
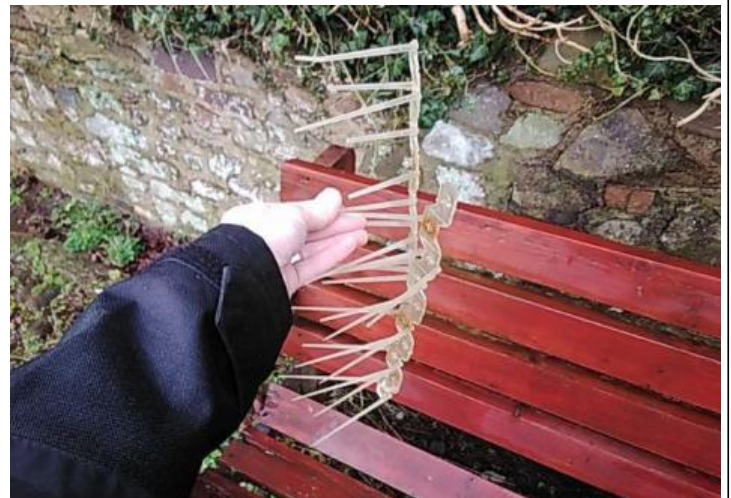
Finding: There are hard needle-like plastic bird deterrent strips on the crossbar. We don't recommend the use of these devices. Two sections had fallen from the crossbar at the time of the inspection

Action: Consider replacing the strips with soft/flexible deterrents e.g. cable ties or similar.
