The Village Hall

Sampford Courtney

**Bat and Breeding
Bird Survey**

**Client: Mr Carpenter
Project no. 212280
Issued: March 2022**

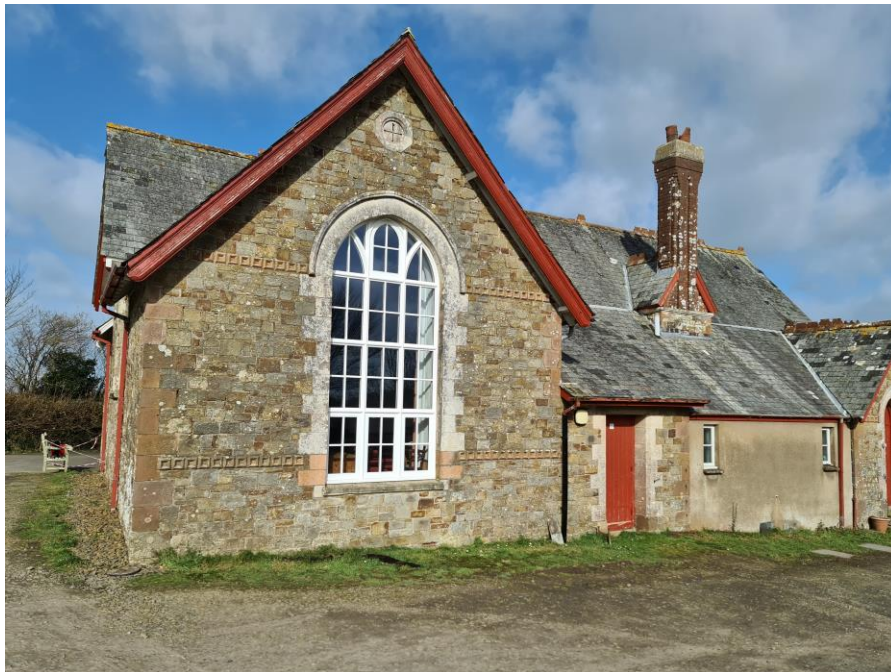
Photograph 1: Village Hall

Potential access points were noted to all aspects with ones of note being found at the eaves, where dormers cut into the main roof pitches and through ventilation slots high in the gable walls (one of these is shown in Photograph 1).

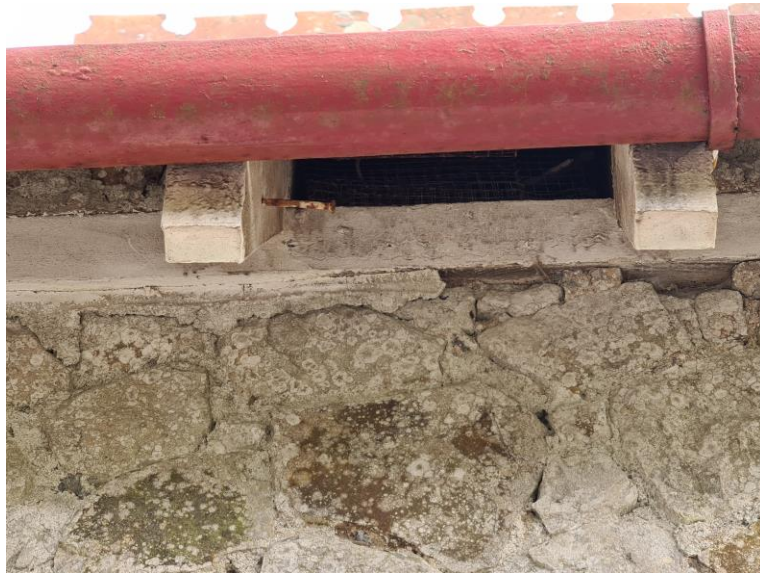
Photograph 2: Eaves level potential access point

There were various potential access points for bats including those shown on Photographs 2 to 4. The eaves level openings extended into the wall top area and a section where the roof covering was boarded beneath offering potential crevice roosting areas. Photograph 3 shows an example of potential bat access points via the flashing around the areas where roof lines keyed into each other. Photograph 4 shows an unmeshed ventilation feature that leads into the main roof space. There were two of the latter (one in each gable). A low number of scattered small bat droppings were noted in the main roof space however it was not possible to tell if these were from prospecting behaviour or roosting.

The potential access points shown on Photographs 2 to 4 were also exploitable by crevice nesting birds. No signs of previous nesting were noted however the eaves access points in particular were of high potential for crevice nesting species.

Due to the presence of potential bat access points it is recommended that emergence surveys are carried out during May and June 2022 to verify if bats are roosting at the site. A minimum of two evening emergence surveys and a dawn re-entry survey is recommended.

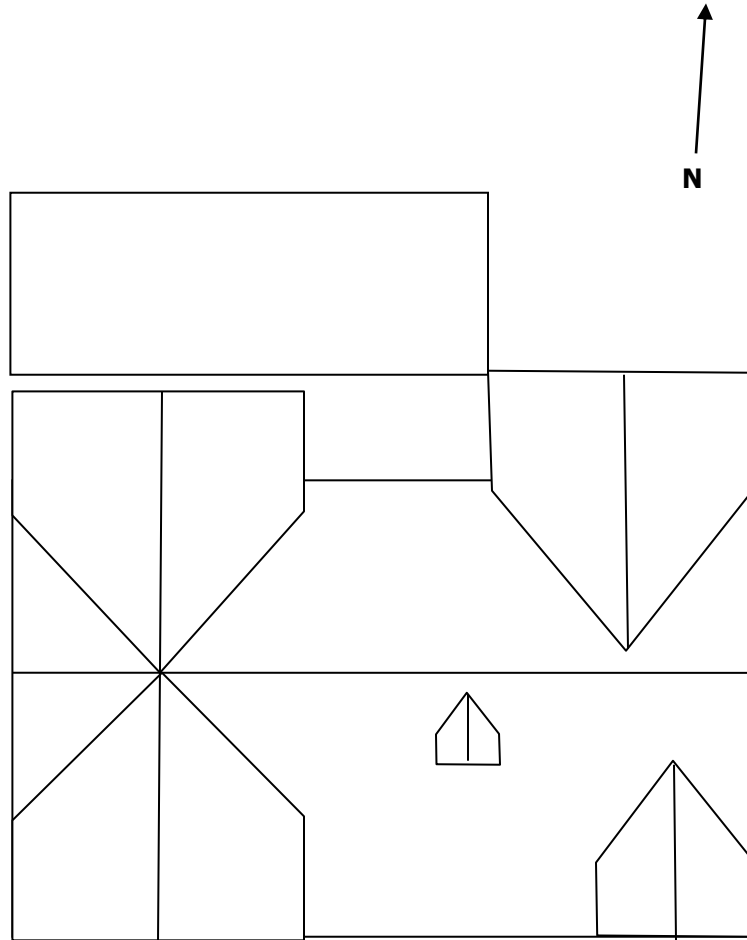
Figure 1: Sketch plan of Village Hall Roof Line

Wall construction	Stone with partial rendering
Roof construction	The roof had a complex layout with a number of areas where the roof pitch changed and cut into the main roof line (refer to Figure 1). The slate roof covering was predominantly unlined although some areas were boarded beneath
