the play inspection company

Annual Inspection

Sampford Courtenay Parish Council

Sampford Courtenay Village Green

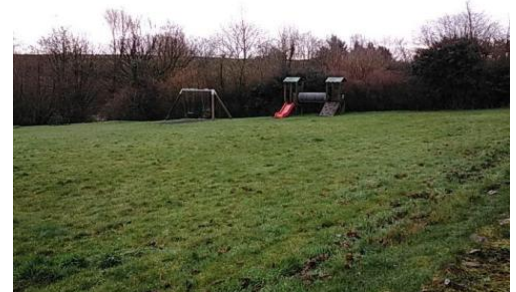
Item: Site General
Manufacturer: Unknown
Surface Type: Grass
Item Quantity: 1
Equipment Compliance: N/A
Surface Area Compliance: N/A

NOTE - There are a number of private access points / gates present on site. These gates have not been assessed within this report. -

There are two domestic, unsecured free standing goals present on site. One of the goals has significant damage. These items are unsuitable for use in a public play area. - We would recommend that the goals are removed

There are trip hazards present over the footpath edgings - Reinstate surrounding surfaces to level to remove the trip points

The path surface is uneven and some of the stones are loose creating potential trip points - Monitor condition and usage of path and reinstate as required.

There is algae, silt or moss growth on the footpath surface resulting in slippery conditions - Clean and treat appropriately

NOTE - Although not part of the inspection, the inspector note a loose cable on the building adjacent to the access point -

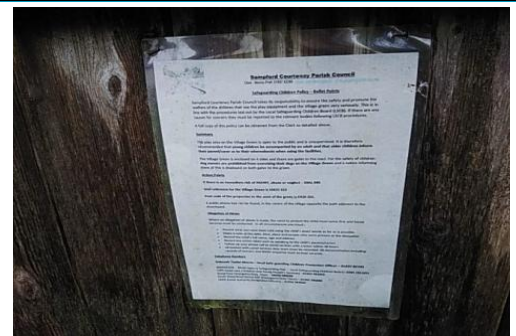
Item: Sign
Manufacturer: Not Identified
Surface Type: Grass
Item Quantity: 1
Equipment Compliance: N/A
Surface Area Compliance: N/A

The sign is of a laminated paper type and will deteriorate over time. The text is also small and may be difficult to read for some users - Consider replacement with alternative signage

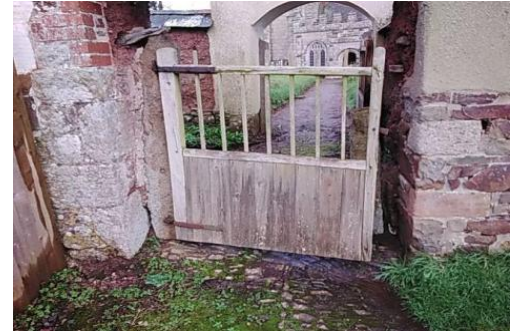
Item: Gate - Pedestrian
Manufacturer: Not Identified
Surface Type: Brick Pavers
Item Quantity: 2
Equipment Compliance: N/A
Surface Area Compliance: N/A

The paintwork on this item has been damaged or worn exposing the metal underneath which is rusting - Treat any rusting components and repaint

The item has missing component(s) - Consider replacing missing components

There are areas or parts of the timber on the structure that have rotted - Replace all affected timbers

NOTE - Although not part of the inspection, it was noted that the adjacent roof and wall had some damage present.
- We would recommend that these structures are made safe

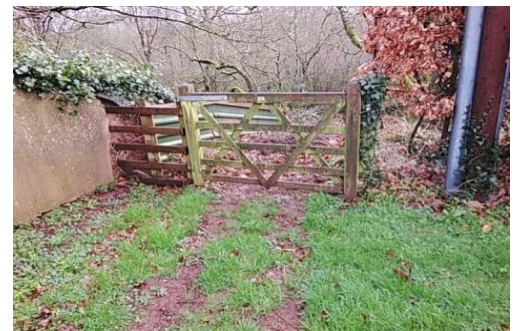
Item: Gate - Maintenance
Manufacturer: Not Identified
Surface Type: Grass
Item Quantity: 1
Equipment Compliance: N/A
Surface Area Compliance: N/A

The item is slightly loose in its foundations - Monitor for any further deterioration and repair as required

There are areas or parts of the timber on the structure that have rotted - Replace all affected timbers

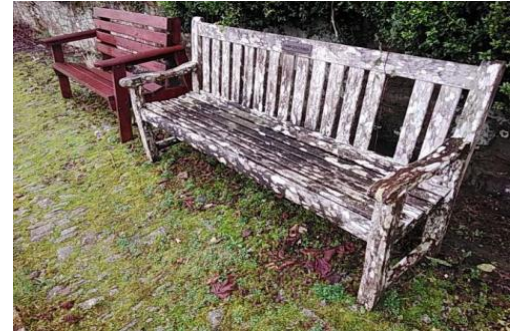
Item: Bench
Manufacturer: Not Identified
Surface Type: Brick Pavers
Item Quantity: 3
Equipment Compliance: N/A
Surface Area Compliance: N/A

There are a number of timber slats missing from the bench - Replace missing slats

The timber stain is in poor condition - Prepare all affected parts and re-stain with an appropriate preservative

There are areas or parts of the timber on the structure that have rotted through structural integrity of the slats cannot be determined - Replace all affected timbers

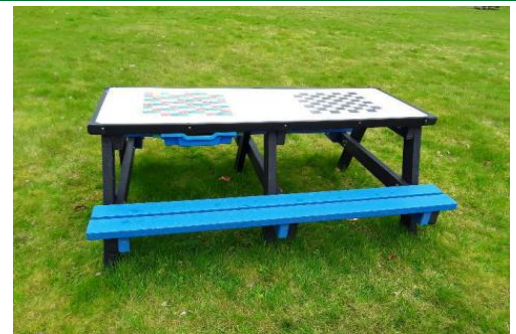
Item: Picnic Table
Manufacturer: Unknown
Surface Type: Grass
Item Quantity: 2
Equipment Compliance: N/A
Surface Area Compliance: N/A

The table/s is/are not secured to the ground and there is some potential for the item/s to be moved within falling spaces of equipment - Secure to the ground

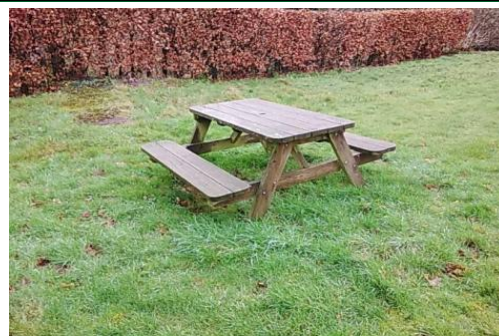
Item: Picnic Table
Manufacturer: Not Identified
Surface Type: Grass
Item Quantity: 1
Equipment Compliance: N/A
Surface Area Compliance: N/A

The table/s is/are not secured to the ground and there is some potential for the item/s to be moved within falling spaces of equipment - Secure to the ground

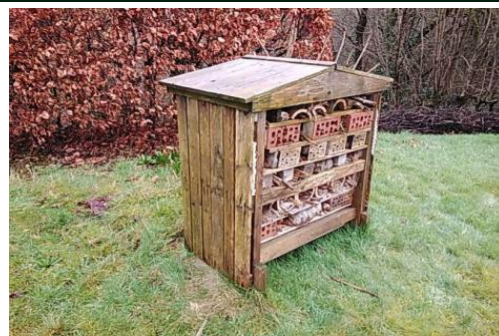
Item: Bug Hotel
Manufacturer: Not Identified
Surface Type: Grass
Item Quantity: 1
Equipment Compliance: N/A
Surface Area Compliance: N/A

The item is secured at the front only and there is some potential for it to tip over - Secure the item at the rear.

There are a number of loose items within the structure, these items may fall out or be subjected to mis-use. - Ensure that an appropriate risk assessment is in place, monitor use and secure or remove as required

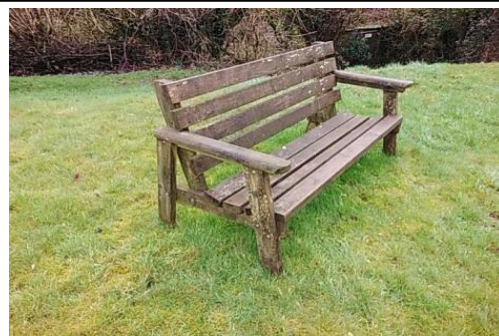
Item: Bench
Manufacturer: Not Identified
Surface Type: Grass
Item Quantity: 1
Equipment Compliance: N/A
Surface Area Compliance: N/A

The bench/es is/are not securely fixed to the surface and there is some possibility of the item/s tipping or rolling over - Secure to the ground

There is some evidence of rot in the timber - Monitor for any further deterioration and replace as required

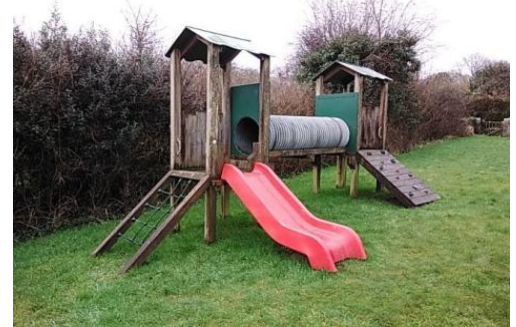
Item: Multi Play (Junior)
Manufacturer: Playline Design
Surface Type: Grass Matrix Tiles
Item Quantity: 1
Equipment Compliance: No
Surface Area Compliance: Yes

There are areas or parts of the timber net frame on the structure that have rotted and sheared - Replace all affected timbers

There is some evidence of rot in the timber throughout - Monitor for any further deterioration and replace as required

The slide is slightly loose on its mount - Monitor for any further deterioration and repair as required to secure

There is or are fixings missing on the roof panels - Replace all missing fixings

There is or are fixings missing on the platform - Replace all missing fixings

There is/are bolt cap covers missing or damaged on the item - Replace missing or damaged bolt cap covers

There is some strimmer / machinery damage apparent on the posts, this can penetrate the preservative applied to the timber and accelerate the rotting process - Monitor for any deterioration (rot) and replace as required

There are areas or parts of two timber posts on the slide tower that have rotted - Replace all affected timbers

There is or are fixings missing on the tunnel surround creating a crush point in contravention of the requirements of BS EN 1176 Part 1 - Replace all missing fixings and secure to remove crush point

There are areas or parts of the timber post on the climb panel tower that have rotted - Replace all affected timbers

There are areas or parts of both timber climb panel supports that have rotted - Replace all affected timbers

There are areas or parts of the timber post that have rotted at the base and around the area where the platform is mounted - Replace all affected timbers

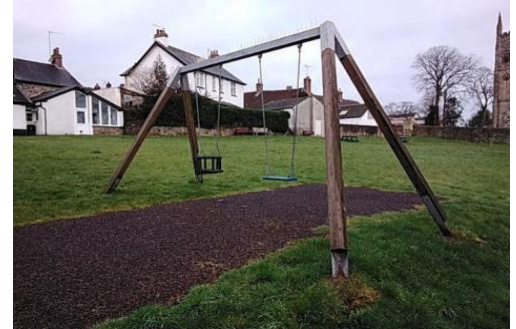
Item: 1 Bay 2 Seat Swing
Manufacturer: Not Identified
Surface Type: Bonded Rubber Mulch
Surface Nominal Depth: 55mm
Item Quantity: 1
Equipment Compliance: Yes
Surface Area Compliance: Yes
Total Findings: 2

There are hard needle-like plastic bird deterrent strips on the crossbar. We don't recommend the use of these devices. Two sections had fallen from the crossbar at the time of the inspection - Consider replacing the strips with soft/flexible deterrents e.g. cable ties or similar.

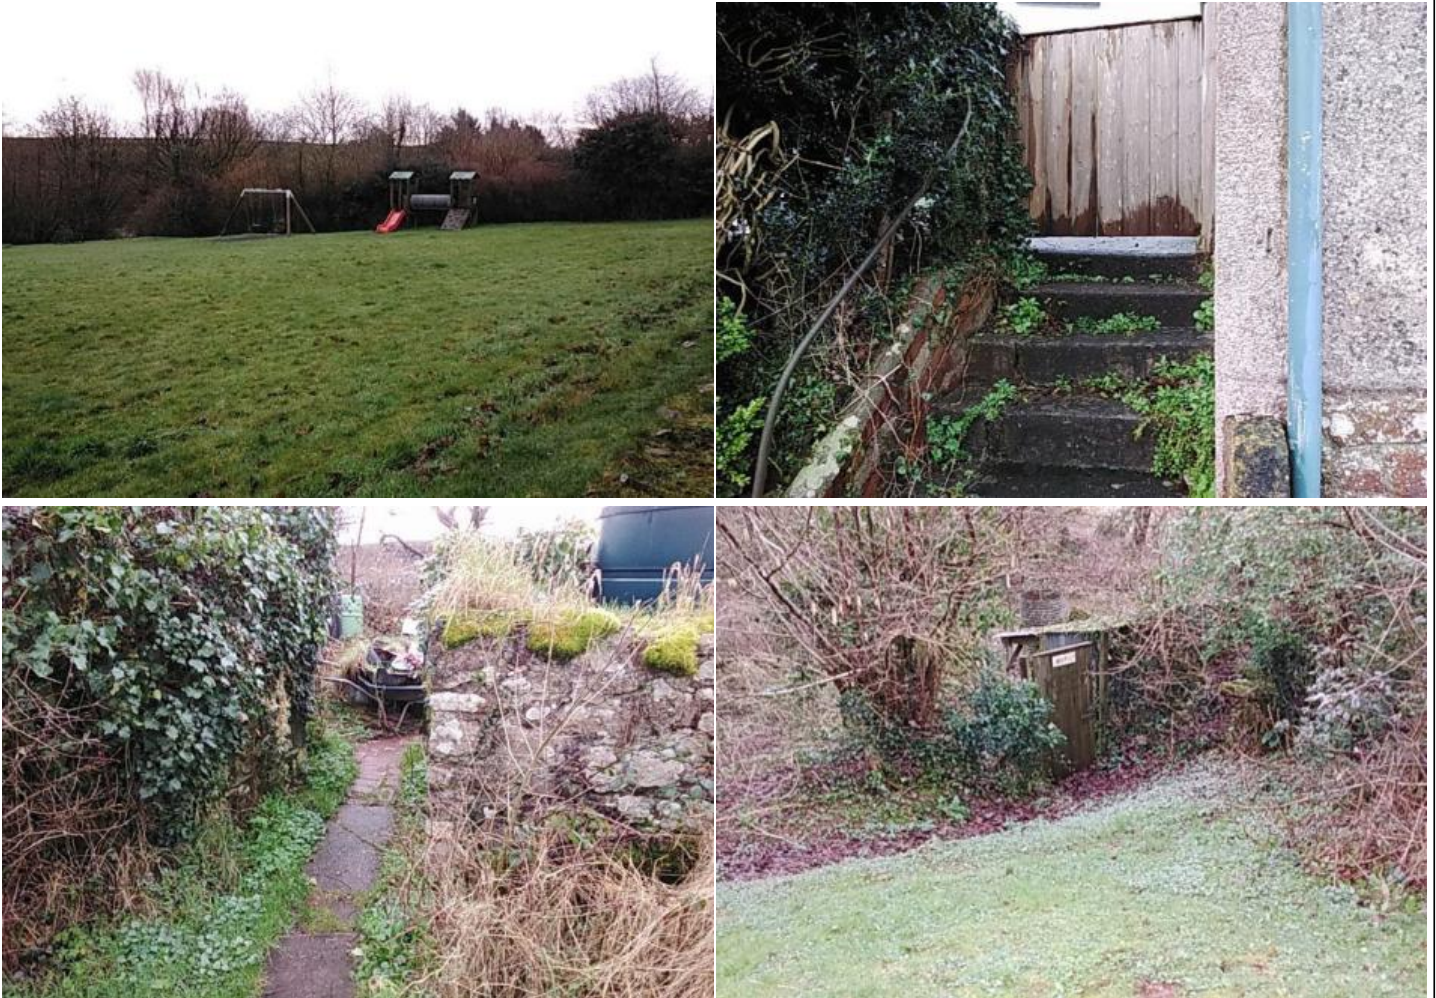
Finding: NOTE - There are a number of private access points / gates present on site. These gates have not been assessed within this report.

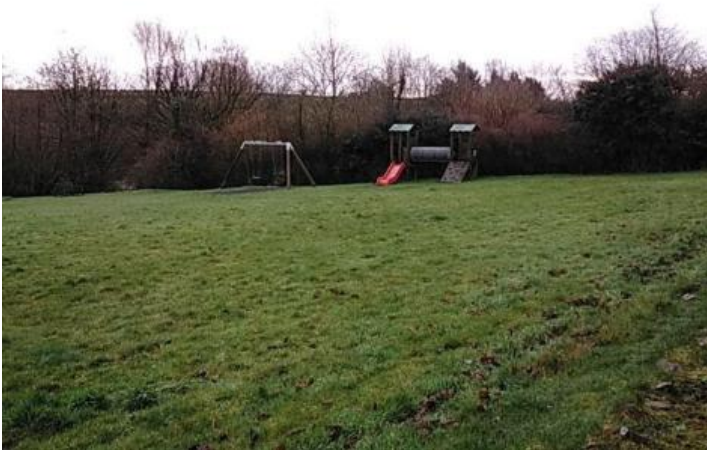
Finding: There is algae, silt or moss growth on the footpath surface resulting in slippery conditions
Action: Clean and treat appropriately

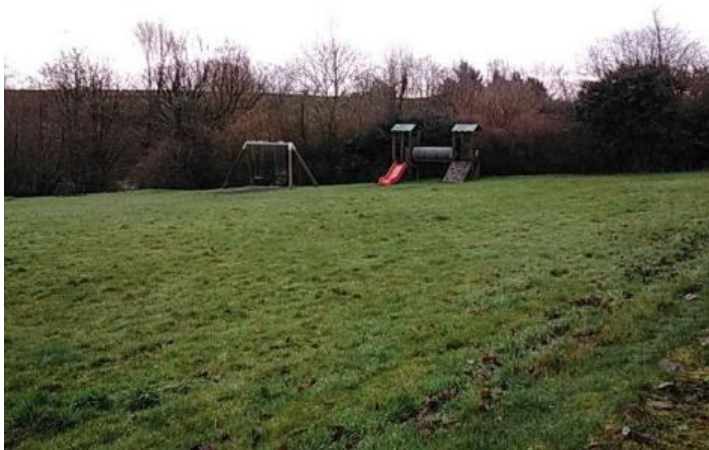
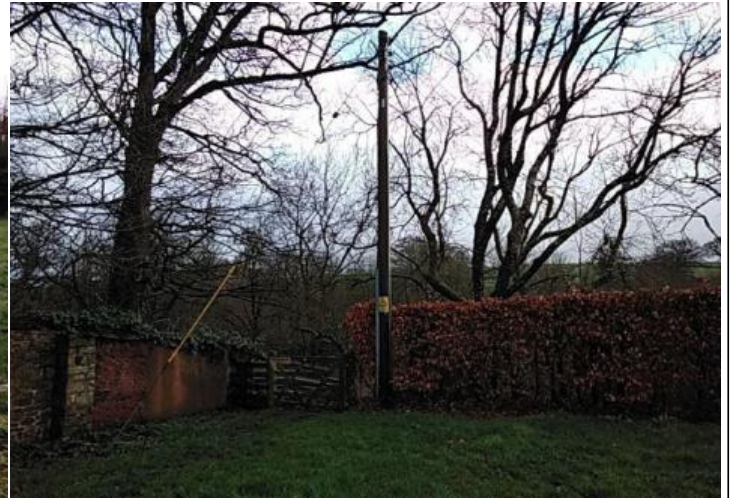
Finding: There are overhead service lines present on / adjacent to the play area

Action: Ensure that an appropriate risk assessment is in place

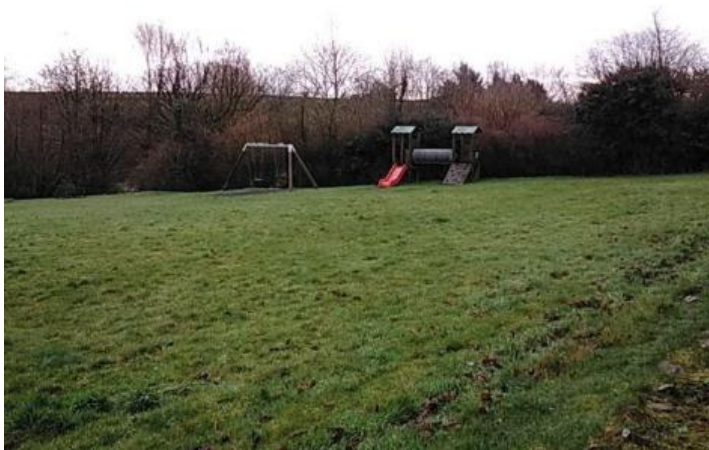
Finding: There are trip hazards present over the footpath edgings

Action: Reinstate surrounding surfaces to level to remove the trip points

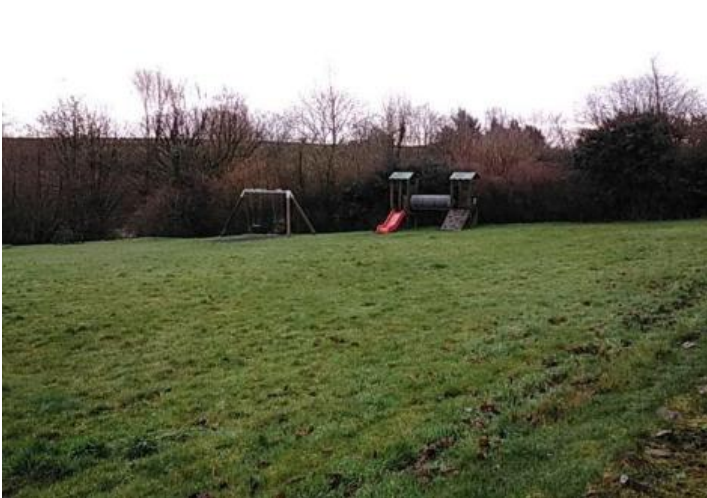
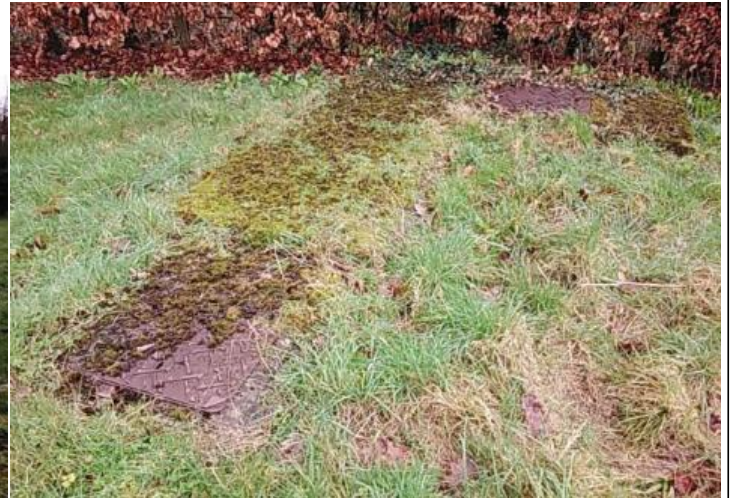
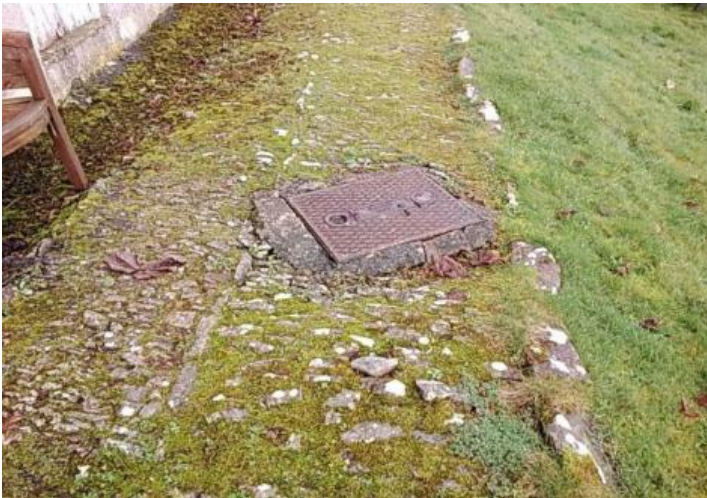
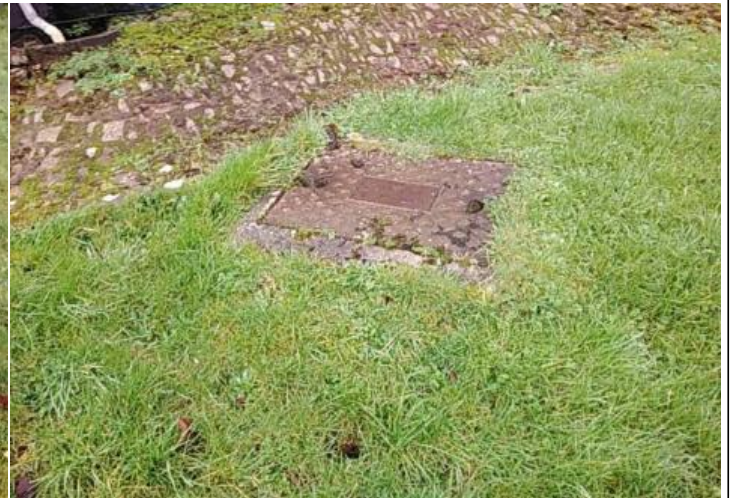
Finding: There are a significant number of manholes present on site

Action: Ensure an appropriate risk assessment is in place and monitor use.

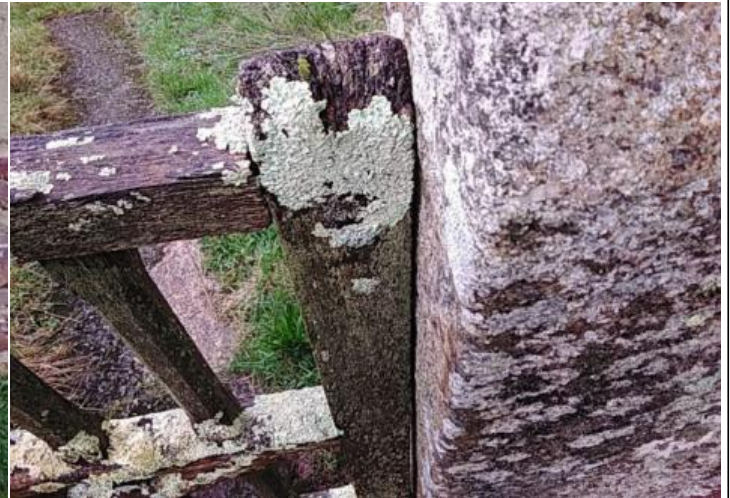
Finding: There are openings that are less than 12mm that could trap or crush fingers

Action: Provide a 12mm gap throughout full range of motion at both sides of gate

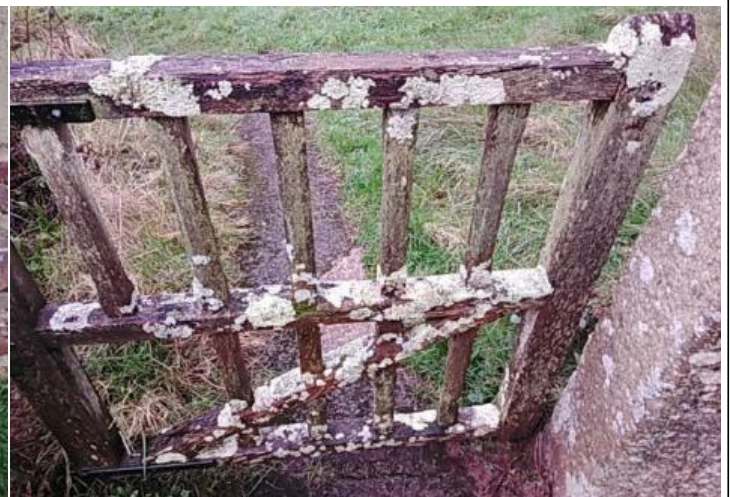
Finding: There is algae or moss on the surface of the equipment

Action: Clean and treat appropriately

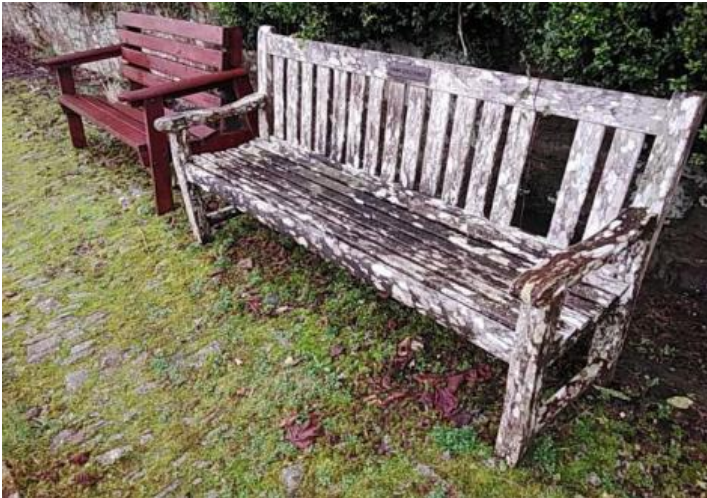
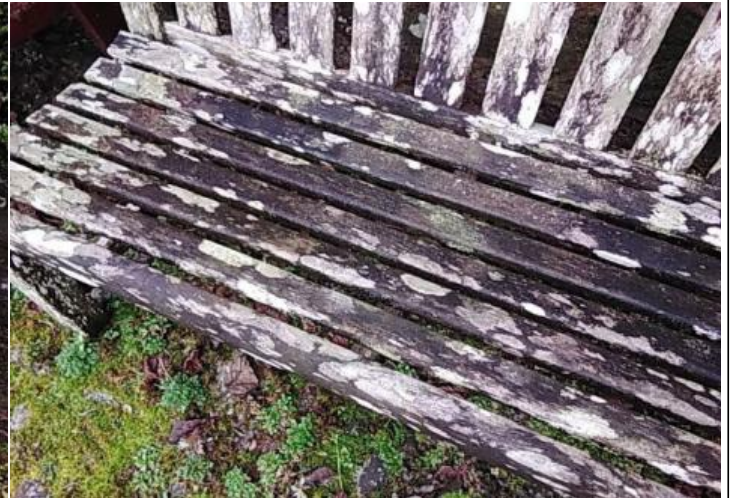
Finding: There is algae or moss on the surface of the equipment

Action: Clean and treat appropriately

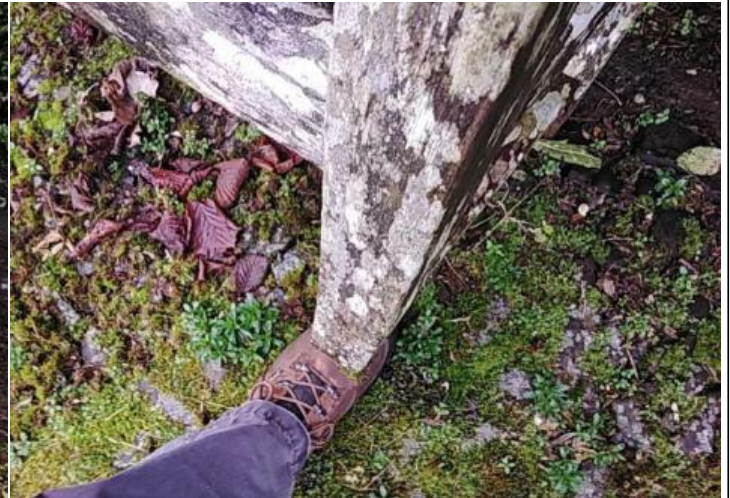
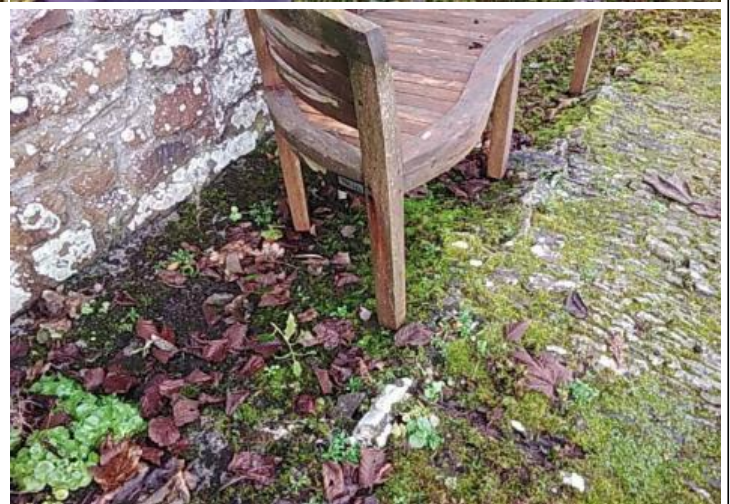
Finding: The bench/es is/are not securely fixed to the surface and there is some possibility of the item/s tipping or rolling over

Action: Secure to the ground

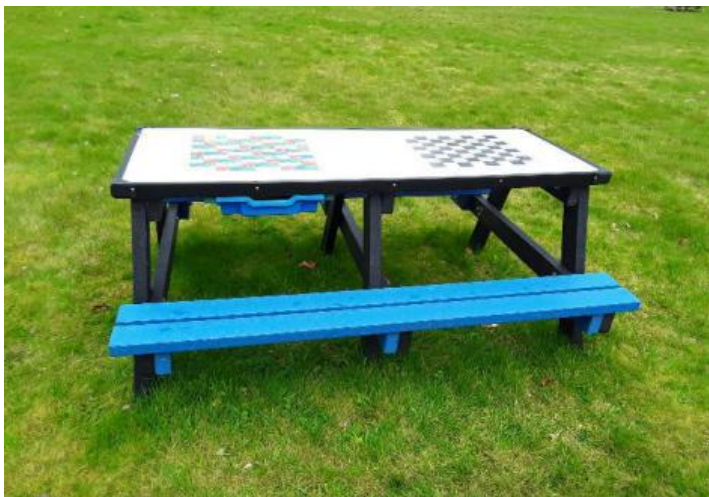
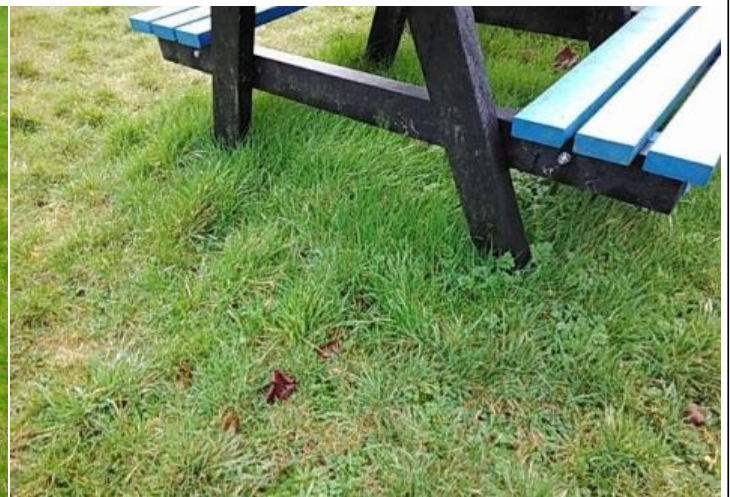
Finding: The table/s is/are not secured to the ground and there is some potential for the item/s to be moved within falling spaces of equipment

Action: Secure to the ground

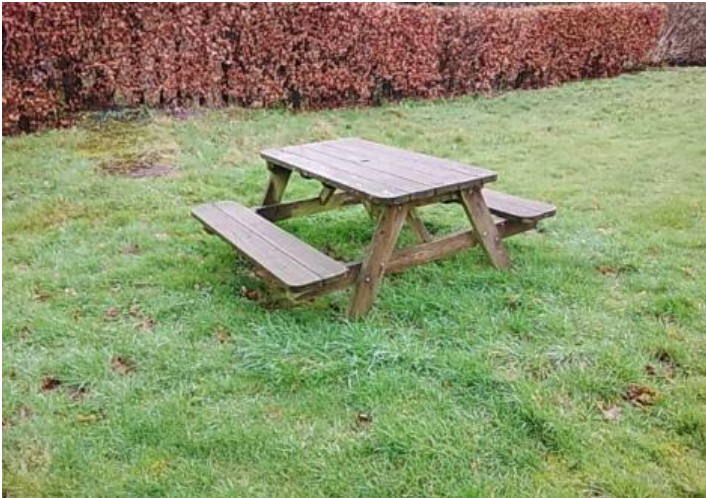
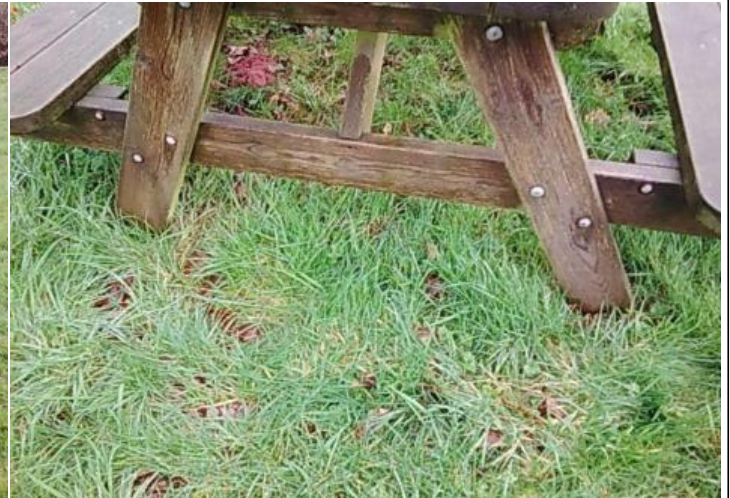
Finding: The table/s is/are not secured to the ground and there is some potential for the item/s to be moved within falling spaces of equipment

Action: Secure to the ground

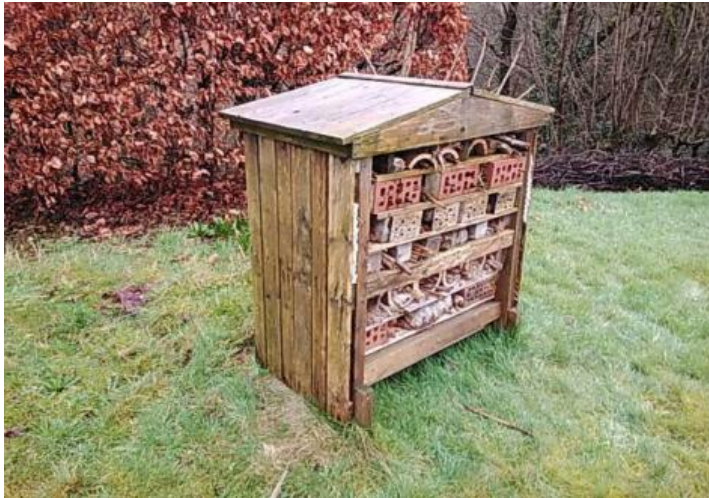
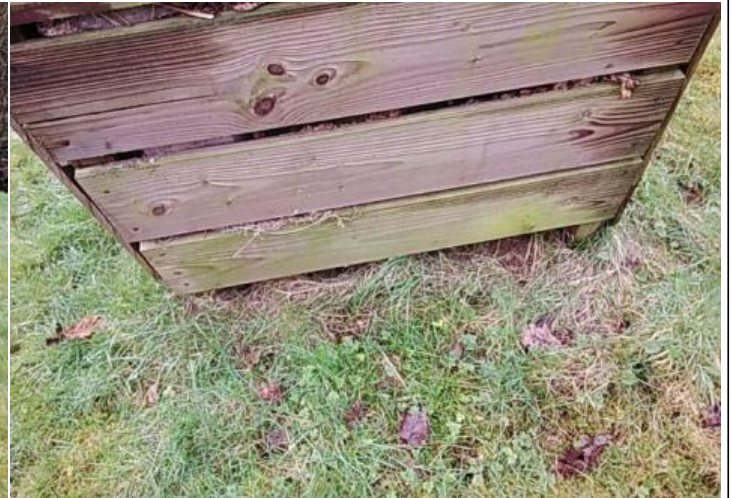
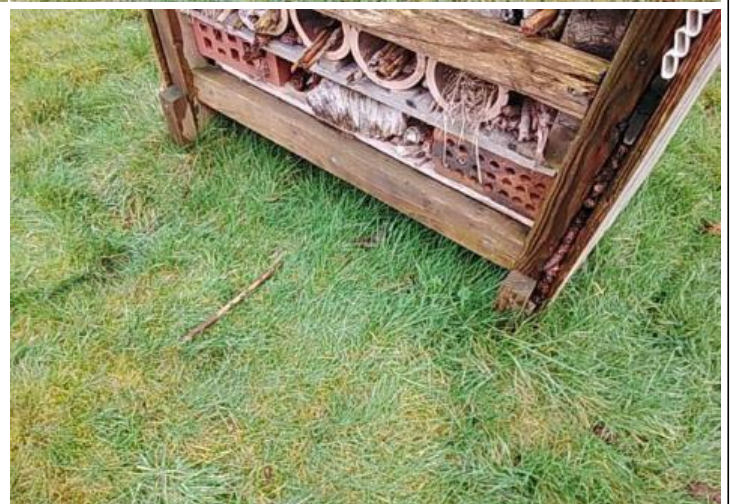
Finding: The item is secured at the front only and there is some potential for it to tip over

Action: Secure the item at the rear.

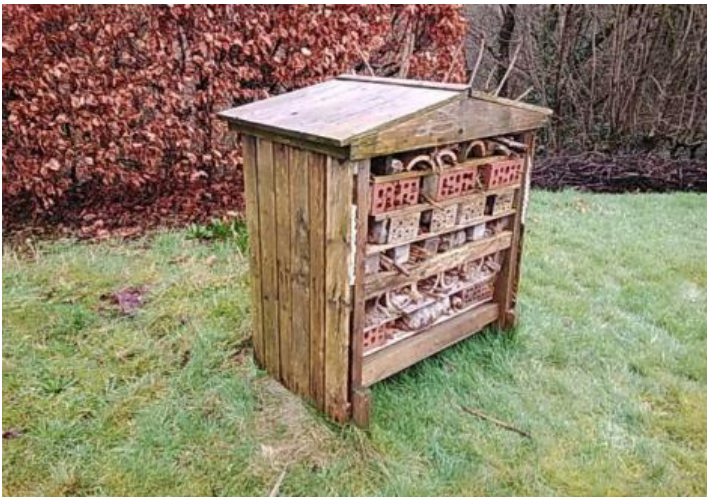
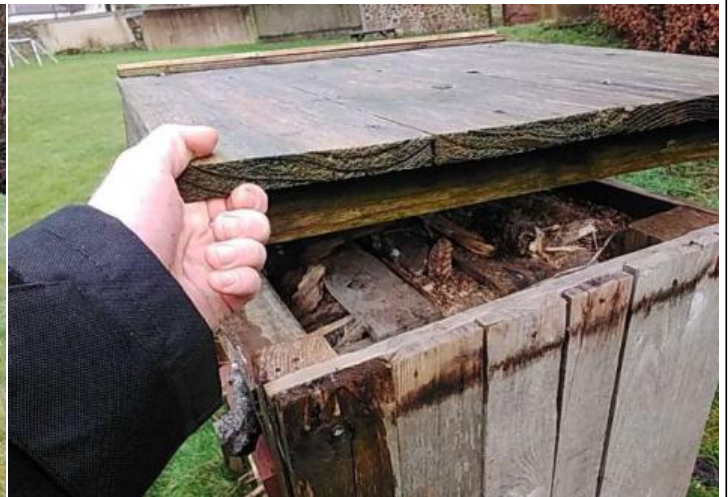
Finding: The lid is not secured

Action: Secure

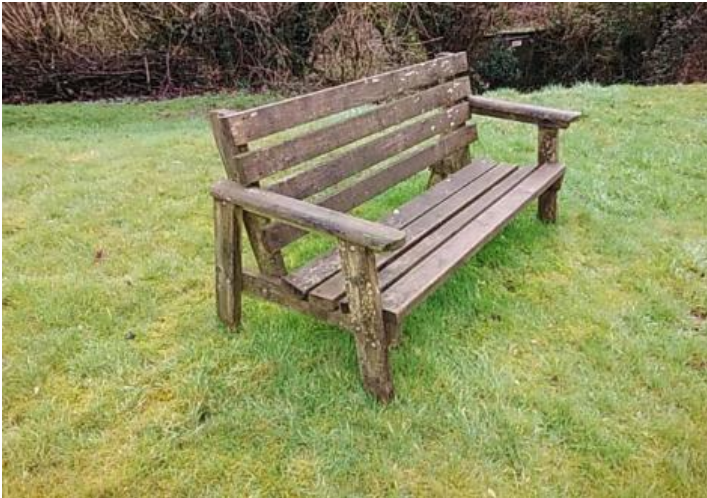
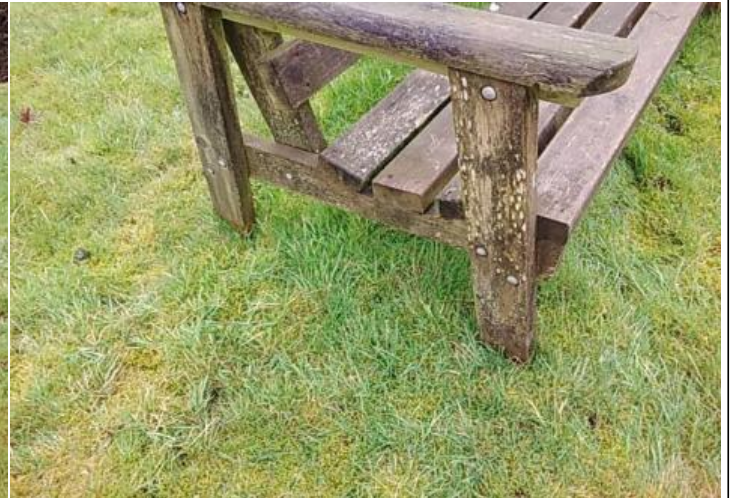
Finding: The bench/es is/are not securely fixed to the surface and there is some possibility of the item/s tipping or rolling over

Action: Secure to the ground

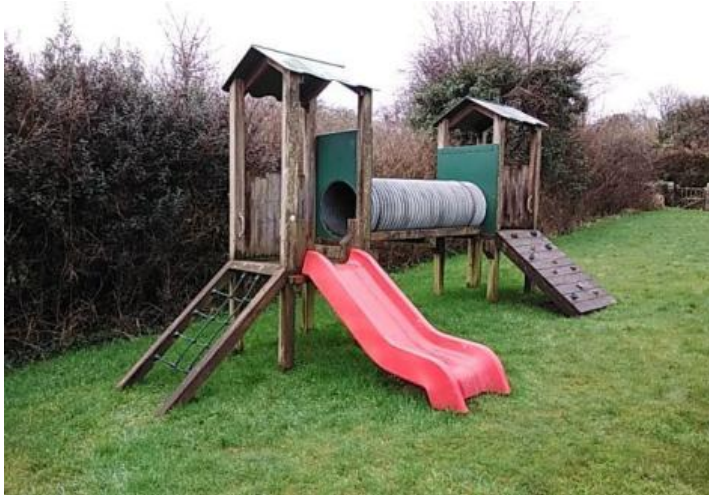
Item: Activity Equipment - Multi Play (Junior)
Manufacturer: Playline Design

Risk Level: M - Moderate Risk
Surface: Grass Matrix Tiles

Finding: There are areas or parts of the timber net frame on the structure that have rotted and sheared
Action: Replace all affected timbers

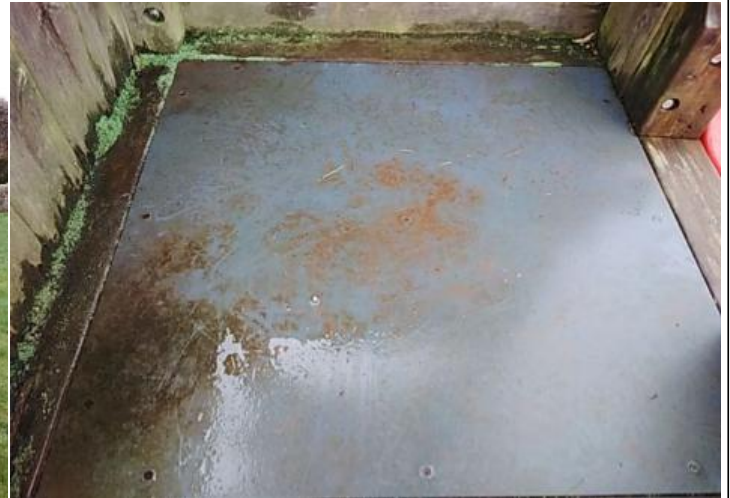
Item: Activity Equipment - Multi Play (Junior)
Manufacturer: Playline Design

Risk Level: L - Low Risk
Surface: Grass Matrix Tiles

Finding: There is algae or moss on the surface of the equipment

Action: Clean and treat appropriately

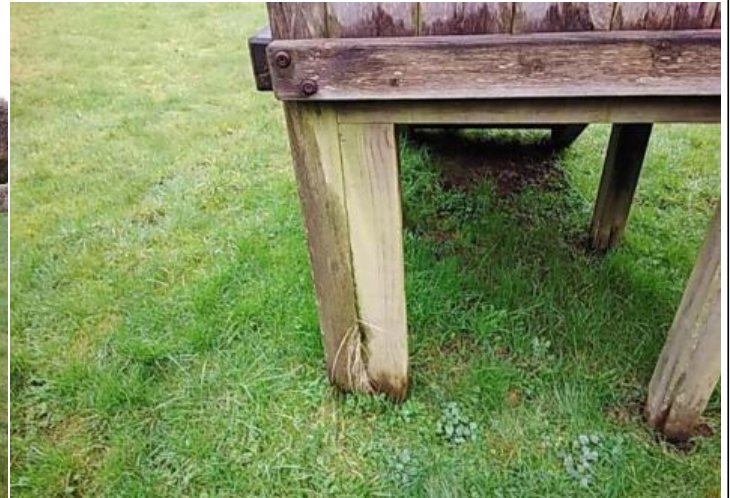
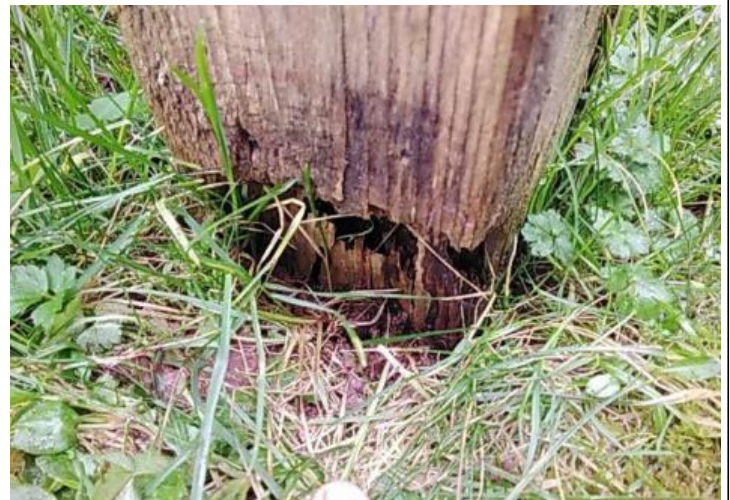
Item: Activity Equipment - Multi Play (Junior)
Manufacturer: Playline Design

Risk Level: N - Risk Assessment not Undertaken
Surface: Grass Matrix Tiles

Finding: NOTE - A post has previously rotted and an additional post has been installed to stabilize the structure

Action: Monitor for any loss of stability / structural integrity

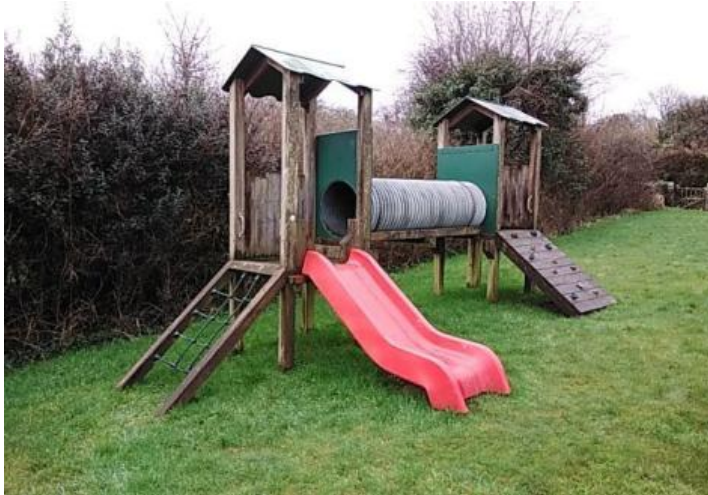
Item: Activity Equipment - Multi Play (Junior)
Manufacturer: Playline Design

Risk Level: M - Moderate Risk
Surface: Grass Matrix Tiles

Finding: There are areas or parts of the timber post that have rotted at the base and around the area where the platform is mounted

Action: Replace all affected timbers

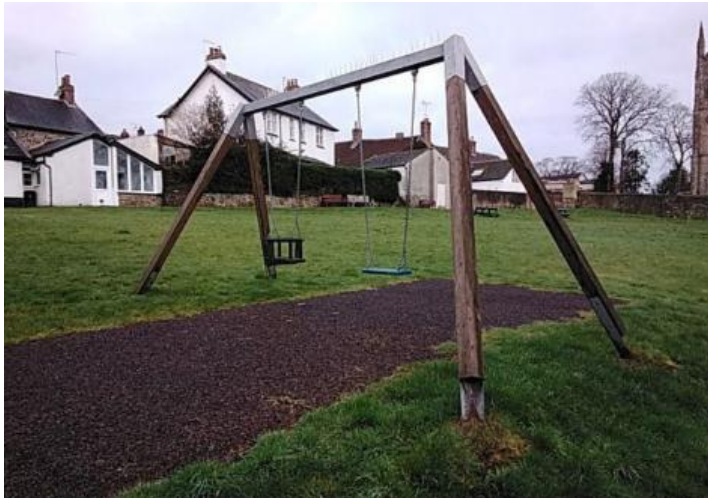
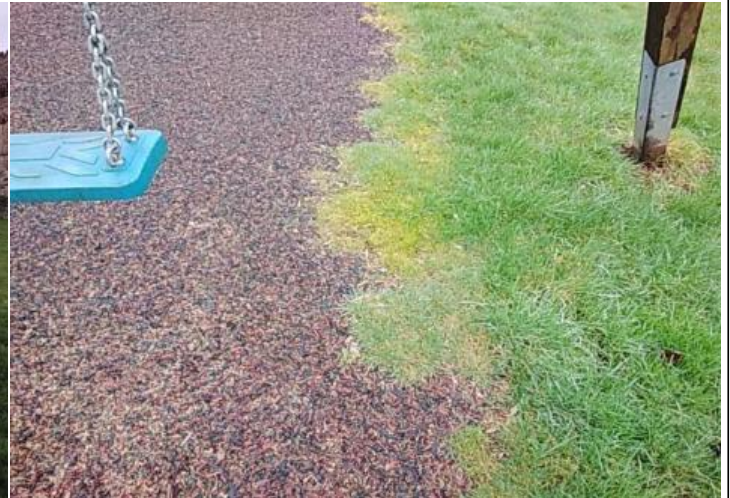
Item: Swings - 1 Bay 2 Seat Swing
Manufacturer: Not Identified

Risk Level: L - Low Risk
Surface: Bonded Rubber Mulch

Finding: There is weed / vegetation growth on, between, or around the edges of the surfacing
Action: Remove weed / vegetation growth
